Rebuilding A Gate – Not As Easy as it First Appeared, Version 1.1

By **R. G. Sparber**

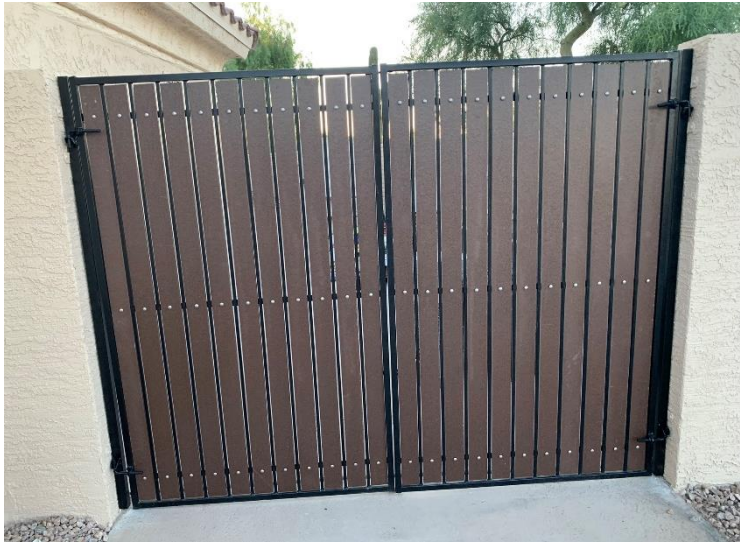
I gain a lot of satisfaction when I look at this unremarkable gate. All slats are simply correctly spaced and square.
