What's Inside a Lectric XP eBike Battery?

Version 1.1

By **R. G. Sparber**

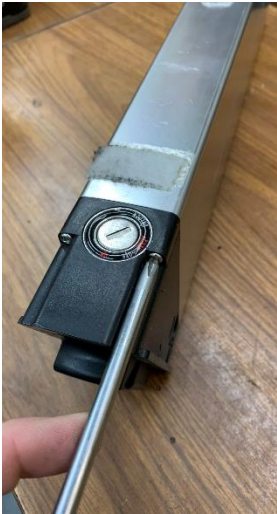
There are three easily accessible screws on each end of the battery. Oh boy, this is going to be easy.

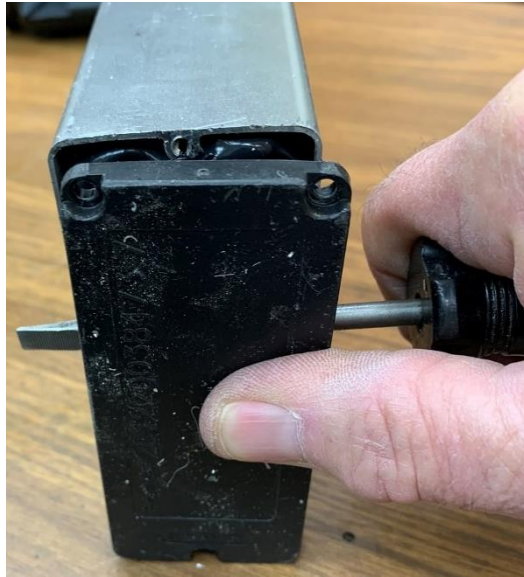
Well, not so fast. It felt like there must be a hidden screw since the back cover was solidly attached. I peeled off the foil serial number label and found no screw. Damn!

Then, I carefully pried the top out and slid a screwdriver between the cover and the first set of cells. With a lot of force, I managed to get the cover off.

That is when I discovered the manufacturer squirted an elastomer into the end before screwing on the rear cover.

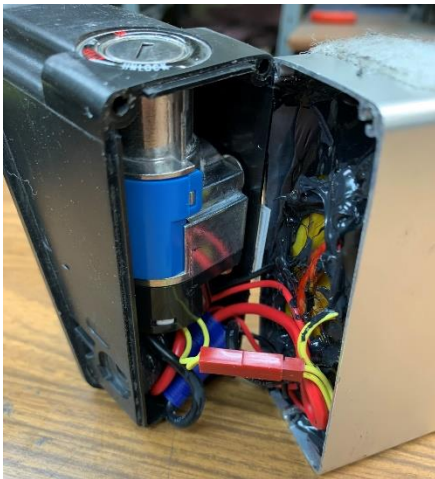
The front end wasn't as bad, but there was a lot of elastomer around the cells.

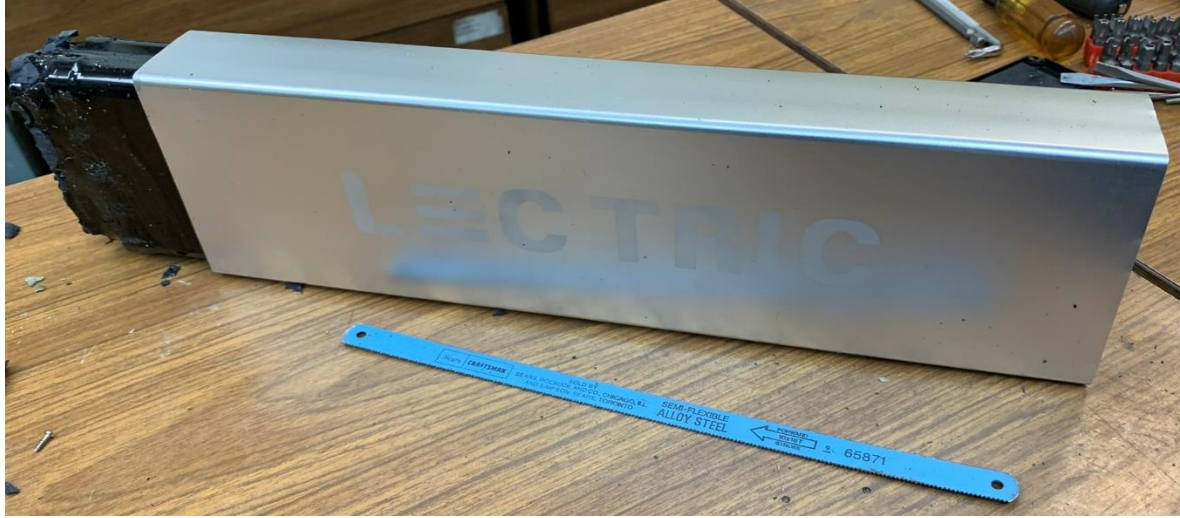
Going against my better judgment, I slid a hacksaw blade between the cells and the inside of the case. I do not recommend doing such a boneheaded action!

I then pushed the package of cells out the front of the enclosure.

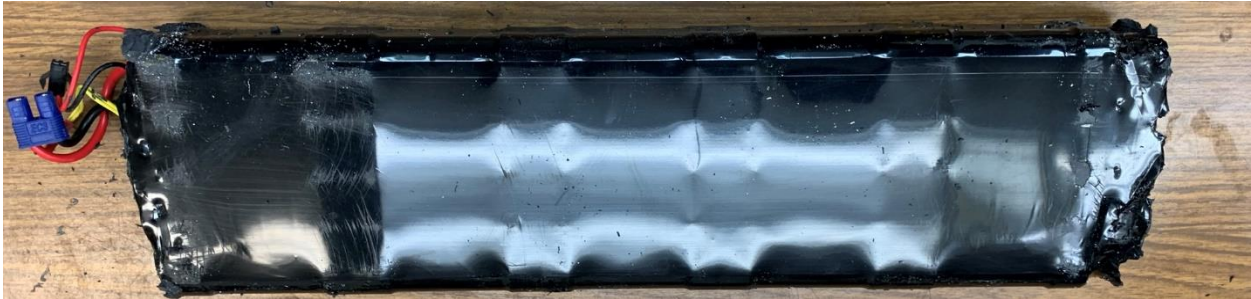
The output terminals and switch were connectorized, so I removed them. The cells and Battery Management System were wrapped in a heavy black plastic film.

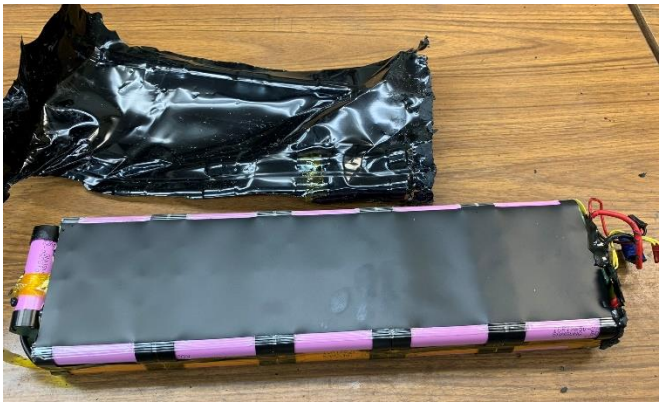
Peeling off this film, I found rigid plastic sheets further protecting the cells. At this point, I discovered that Lectric had used Samsung 18650 29J cells.

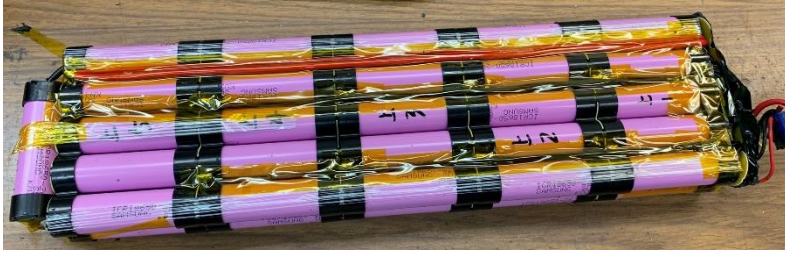
A total of 52 cells are present. The battery is nominally 48 volts, so it takes 13 cells in series ($13 \times 3.7V = 48.1V$). Dividing 52 by 13 says we have four strings. The peak total output current is 20 amps, meaning

each string must put out 5 amperes peak.

Four cells are wired in parallel to form what I call a group. Thirteen groups are wired in series to produce 48 volts. Given identical cells, when the battery sources 20 amperes, each cell will source 5.0 amperes.

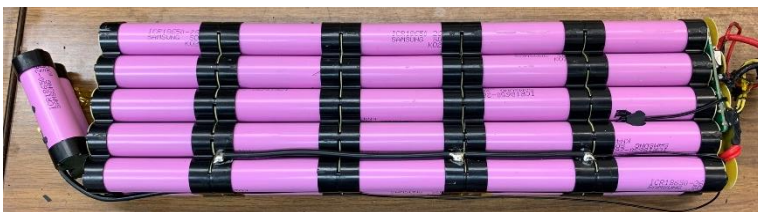
The manufacturer used a generous amount of Kapton tape over all wires plus black tape over all terminals for added protection.

After peeling off the tape and unsoldering all balance wires, I felt I was near the point of no return. I would need to buy a roll of Kapton tape to replace what I just stripped off.

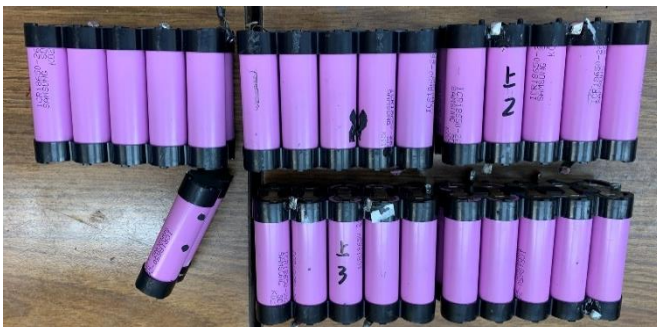
Using my voltmeter, I measured the voltage between all balancing tabs. They gave me access to all parallel groups of cells. Alas, all read 4.1 volts, which is normal. If I had measured around 3.5 volts, I would have torn down that group to isolate the defective cell.

At this point, my ambitions were reduced to collecting individual LiPo cells. I desolded the groups and performed a final voltage check. All still read 4.1 volts. A load test might expose

one or more weak cells, but I had no desire to reassemble the battery.

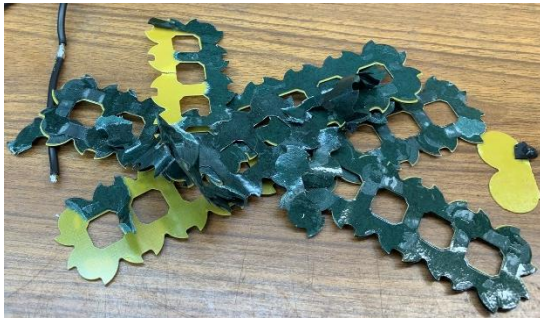
I had already removed many delicate insulators that would not stand up to being reglued.

I did try to follow the conductors to see how they interconnected the cells. All I can say is that whoever figured this out must also play a mean game of chess.
