Gingery Shaper Surface Tests, version 4

By R. G. Sparber

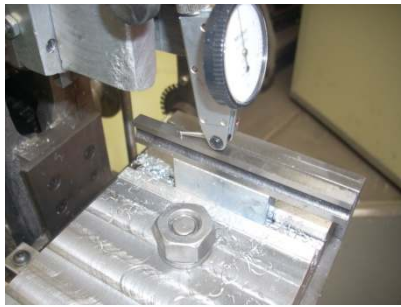
This sample was cut with the vertical jack screw loose, minimum table feed, and minimum speed of ram. The cutter is a shear set at 45° . My DTI across this surface shows less than a $0.0001''$ ripple. The Hi-Spot shows that the surface has evenly distributed peaks.

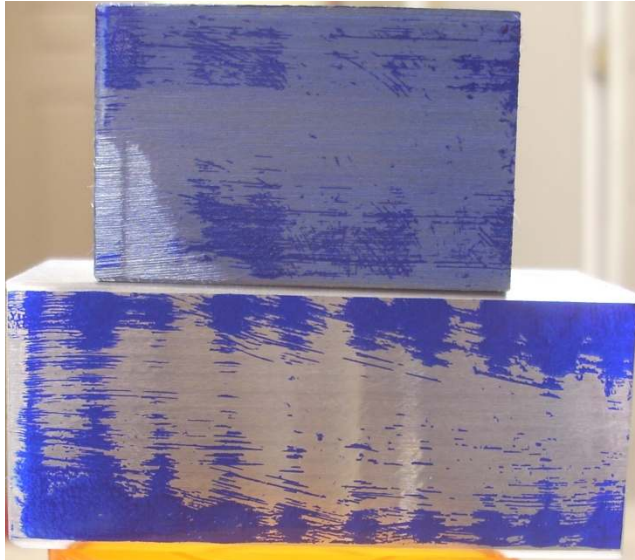
This sample is $1''$ wide. The shaper is set to minimum speed and minimum cross feed. The cutter is a shear set at 45° .

I again used Hi-Spot to make the ripple easier to see. The blue around the edges tells us that it is higher than in the middle. The short lines of blue in columns indicate the peaks of the ripples. The height change here is less than $0.0002''$. The left end of this sample was closest to the shaper’s column during machining.

The ripple has a period of approximately $0.23''$ although some variation is evident.

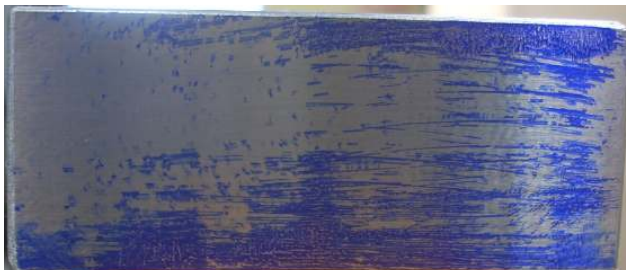
In this sample of aluminum, the block was moved closer to the column. The wider strip on top was cut normally. The narrower strip on the bottom was cut with a heavy weight resting on the head. It cut deeper but what I find more interesting is that the ripples are in the

same place. That may be telling us that it is not a resonance condition. It might be telling us it is in the ram ways. The curved lines seen on the top strip match the ripples formed by my finger applying the Hi-Spot to the surface plate with my finger inside a plastic glove. When you are looking at 0.0001" ripples, it doesn't take much height to show through.

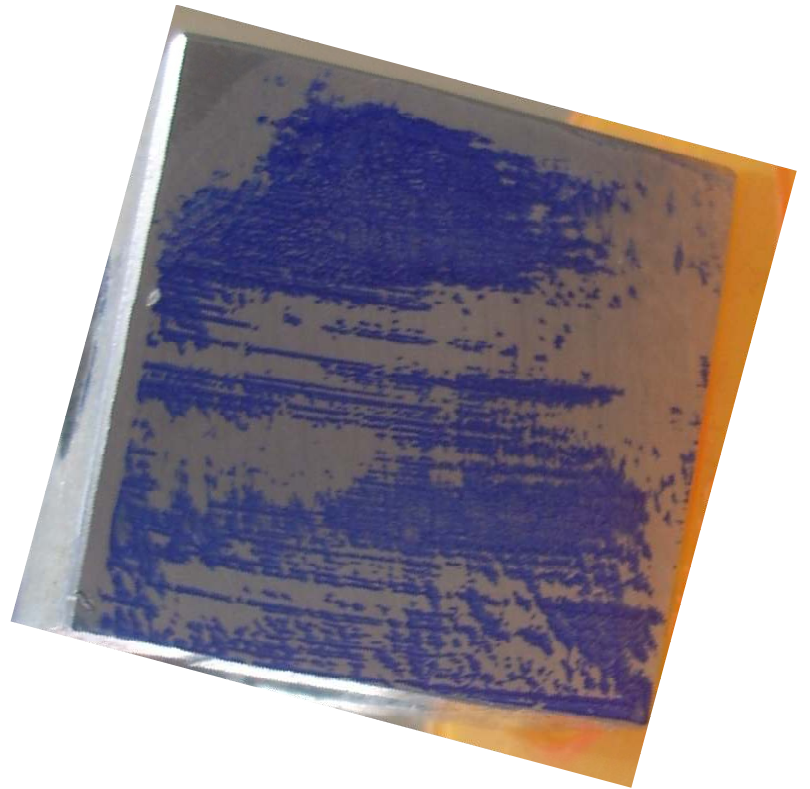
As per John Martin's suggestion, I turned the block so the initial contact of the cutter was not perpendicular to the motion of the ram. It seems that this reduced the ripple. It does appear to me that the ripple is still perpendicular to the ram's motion and not the edge of the block.

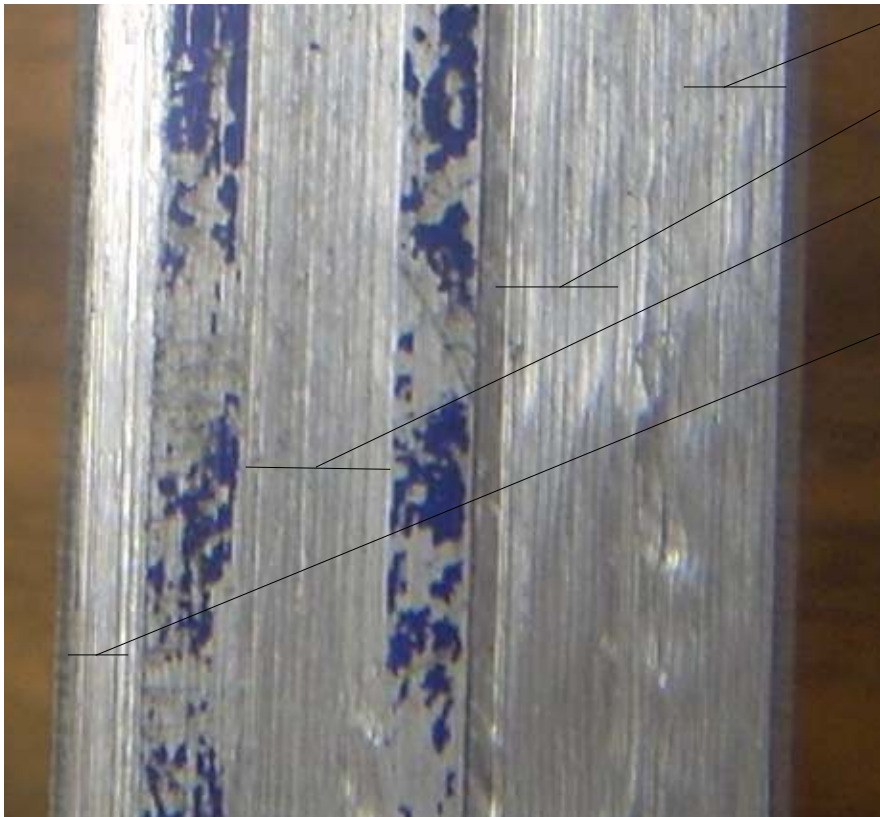
There has been a lot of speculation as to why I get a slight ripple in my cut surface using a shear style cutter. Here is some real data to discuss. In all cases the table advance was at maximum. The picture was taken through a magnifying glass and then I cropped a small part of the picture and expanded it on the PC. The material is 6061 aluminum. My depth of cut is around 0.004" and my advance is around 0.01"
