Defects but No Failures

By R. G. Sparber

12/15/2007

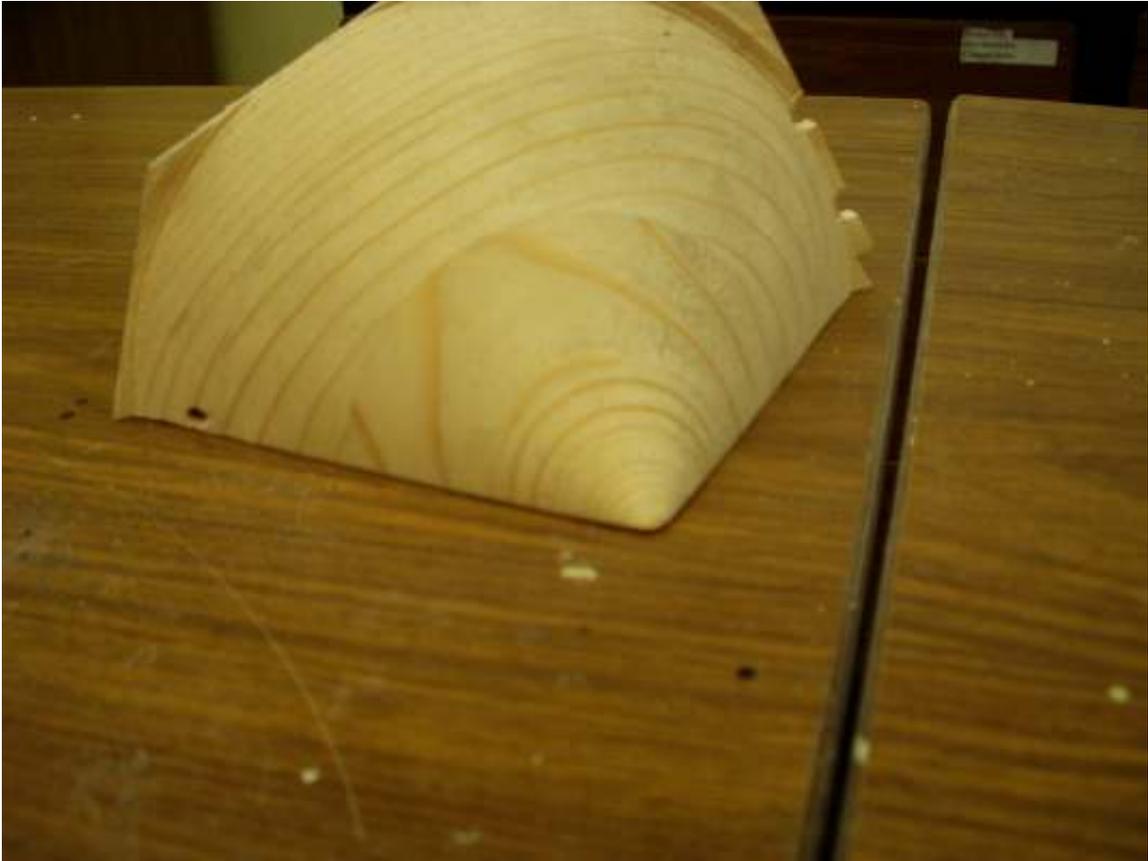
I then used a handsaw to cut the cone in half. This was followed by cutting out the sectors shown in the drawing. In the end my gluing job was poor and bit of wood fell off. That was easy to fix but the resulting sectors just did not look so good. Not much learned on this one but glad I did not use these side lobes.

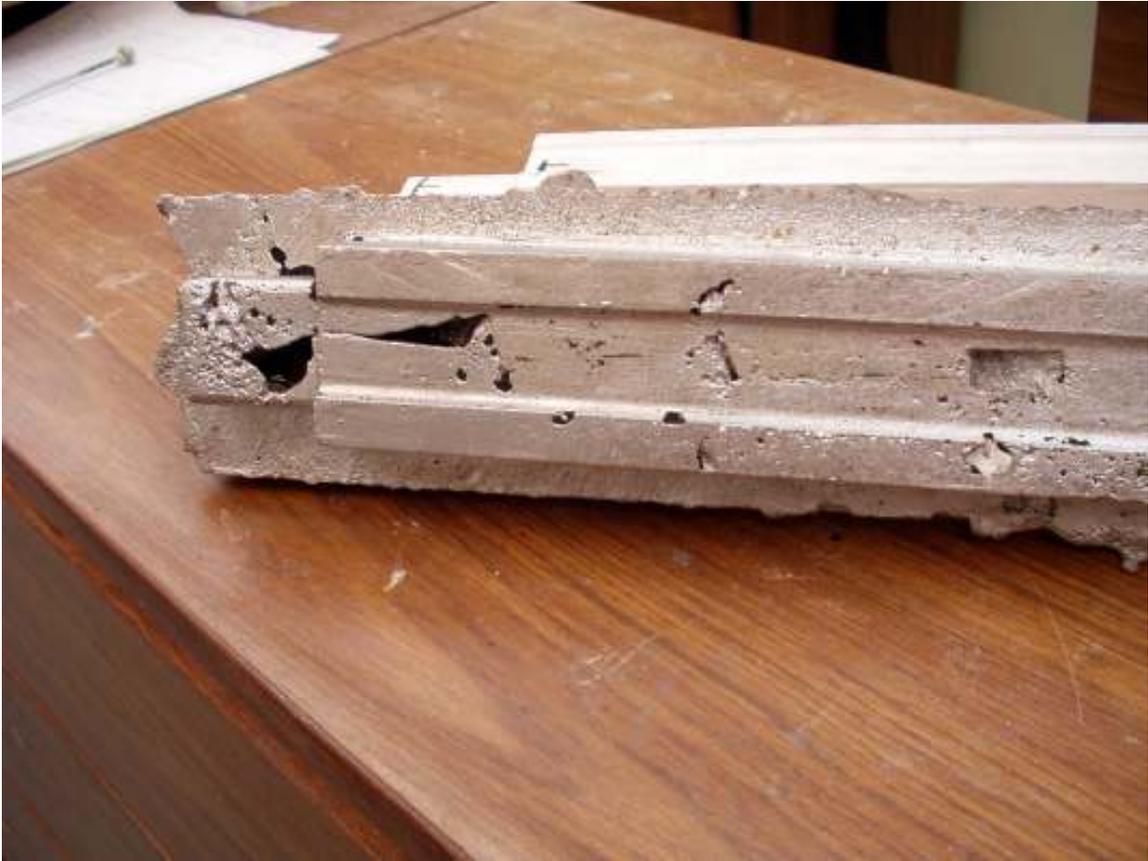
I carefully moved the drag to the pouring area and then the cope. All went well. Then I lowered the cope onto the drag and discovered that one of the guide pins was slightly out of alignment. The little bump caused by this misalignment was enough to cause my third drop out. It was not as massive as the first two and I figured I had nothing to loose so went ahead with the pour.

All of these voids had sand in them. I did not see any porosity. Note the areas that were not spoiled. They are nice and square. The on the left end is part of my riser system. I think it was part of my problem in that it unduly weakened the cope.

1. Don't give up! Well, I actually knew this lesson but it is good to know when to take a break...
2. the riser was too close to the pattern which left pieces of cope that were too narrow to support themselves; I will try pencil risers resting on top of the cope pattern next time
3. It was worth doing the pour because I can see that if there had not been drop out, it would have been a good part.

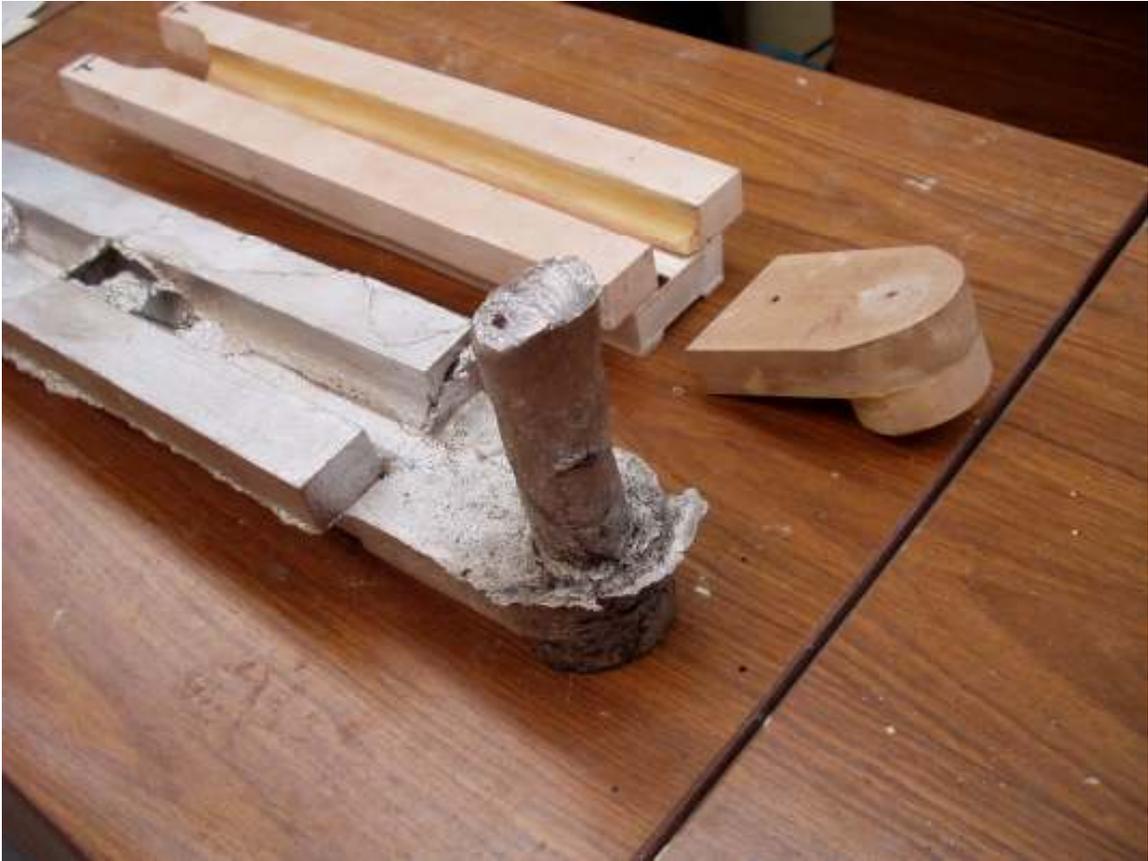
Here you see the sprue and gate next to their pattern. They seemed to work well. My goal was to have a nice even flow into the casting. The downward force of the aluminum falling down the sprue was absorbed by the void below the sprue. The extra wide gate slows the flow while distributing it across the casting impression.

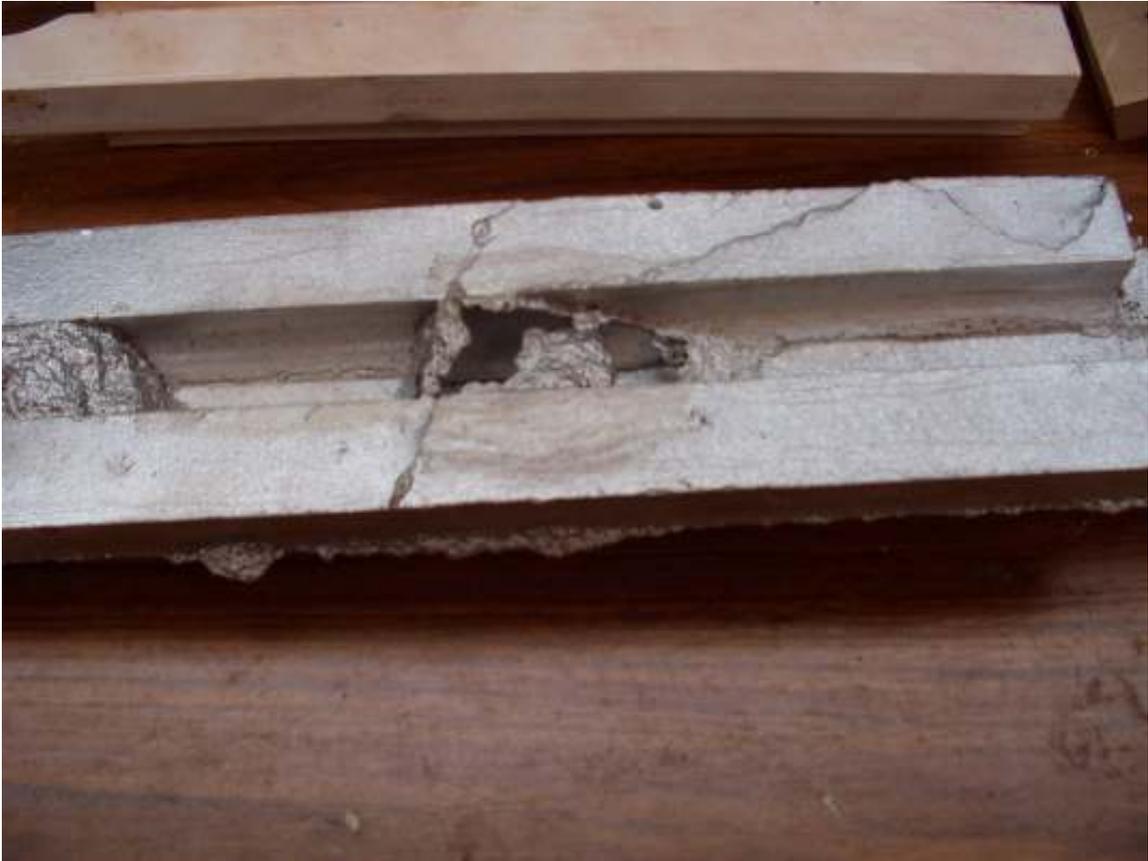
Here you see the fault line in the cope. Lots of sand fell down to provide more room for aluminum. If this was the extent of the damage, I could have milled it out.
