# RF-30 Mill/Drill: What Gives?, Version 2.1

By R. G. Sparber

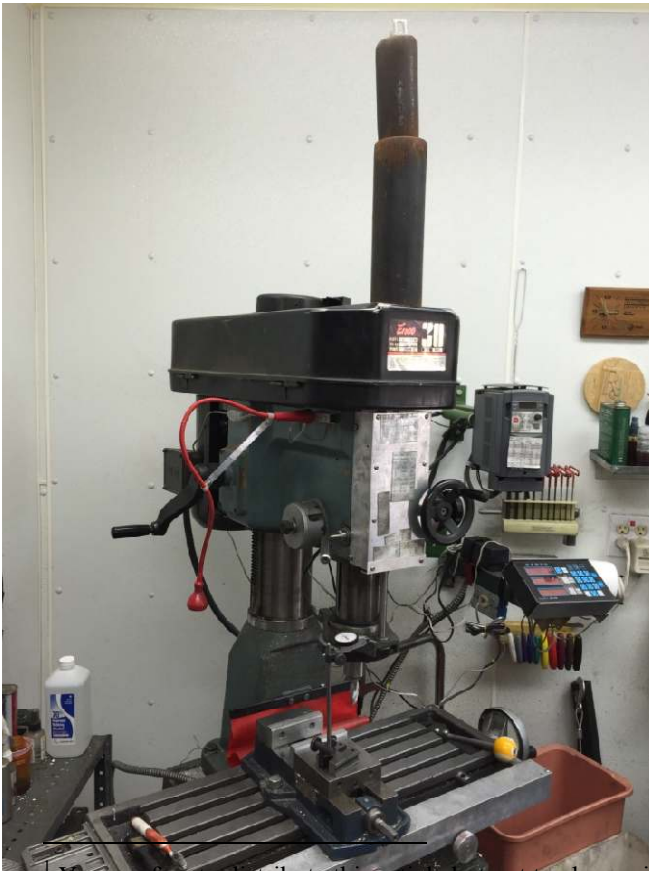
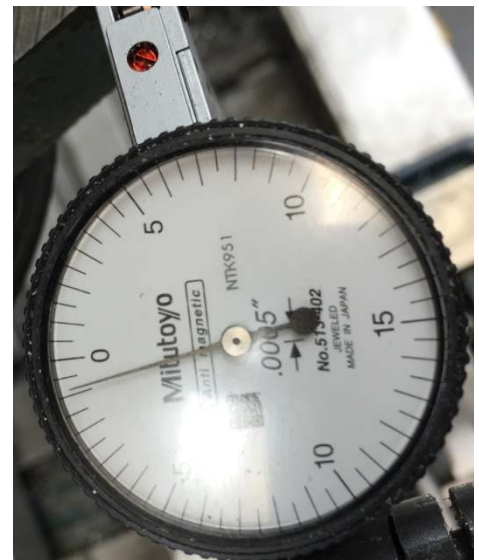
## Test 1

The DTI is supported by the vise and the finger is touching the top surface of the spindle bearing support. I first zeroed the DTI with no weight on the belt cover. Then two steel cylinders are placed and the DTI read again. Finally, the weights are removed and I verify the DTI again reads zero.

I measured a drop of 0.0009".

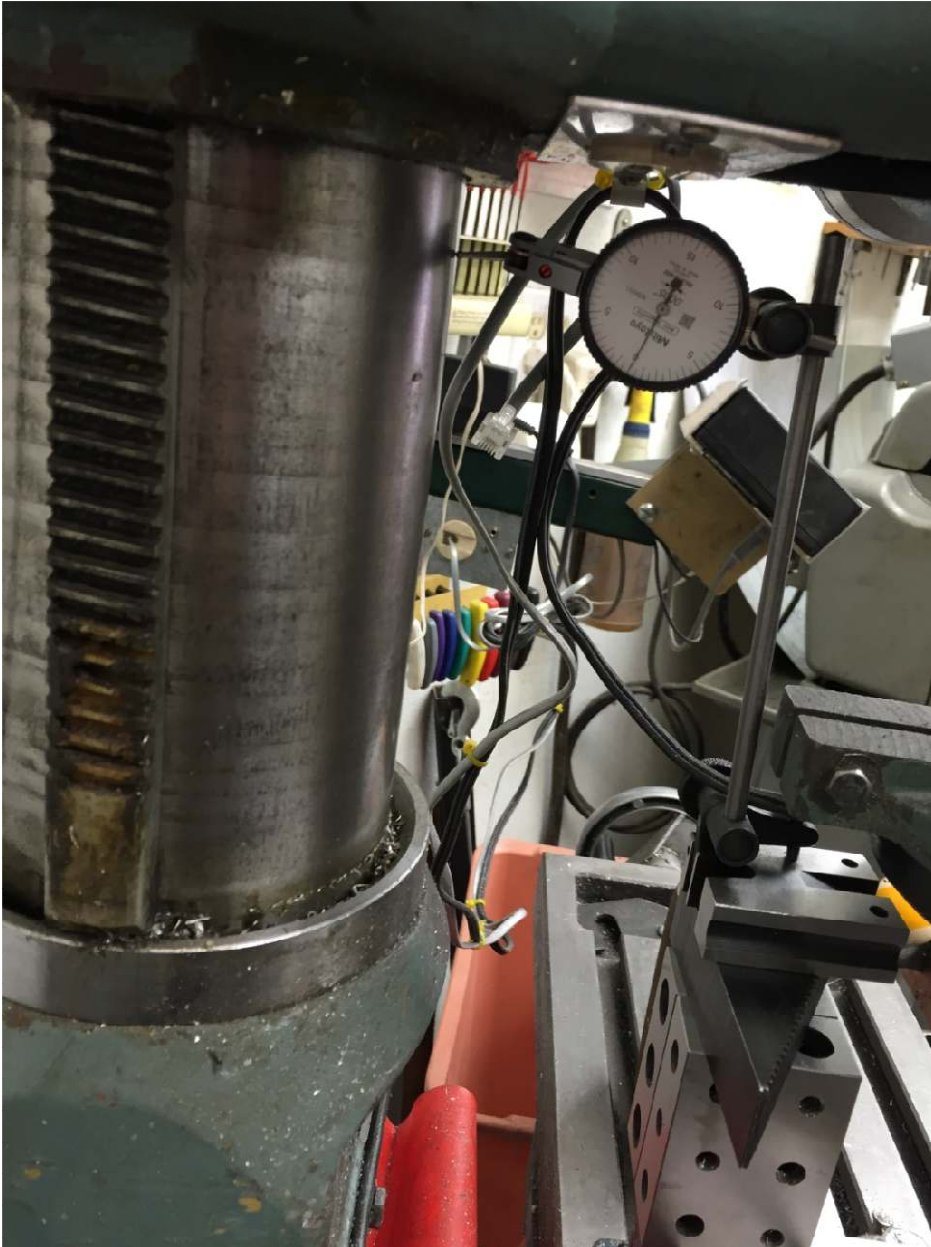
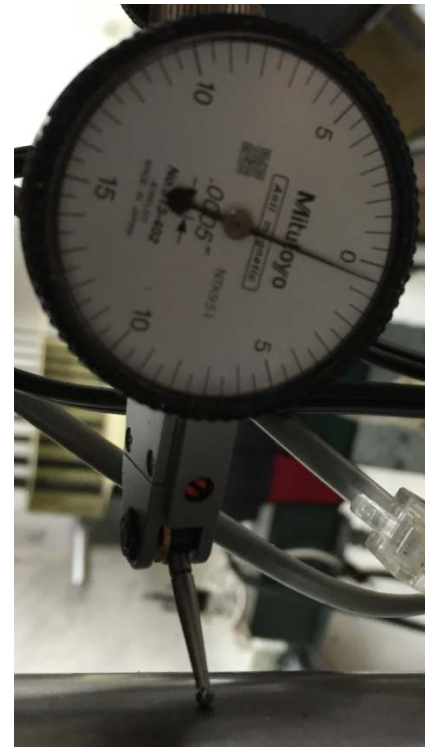
## Test 2

The DTI is supported by the table. The finger is touching the column 1" below the bottom of the head.

I saw a 0.0005" forward motion.

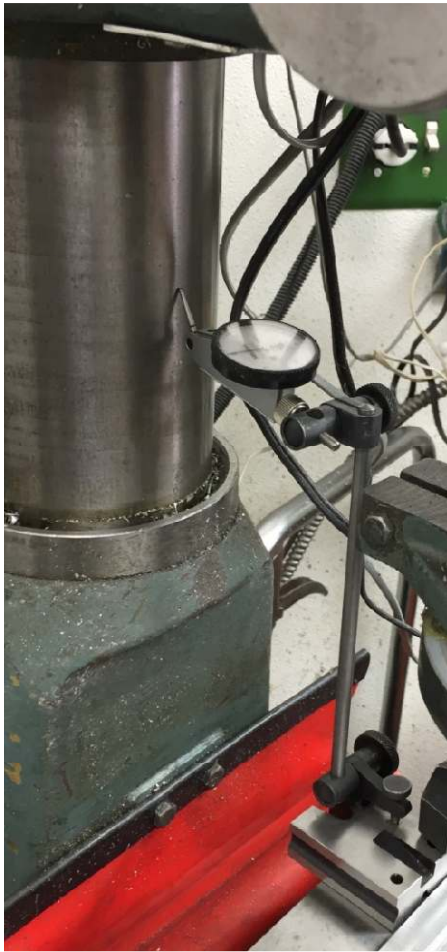
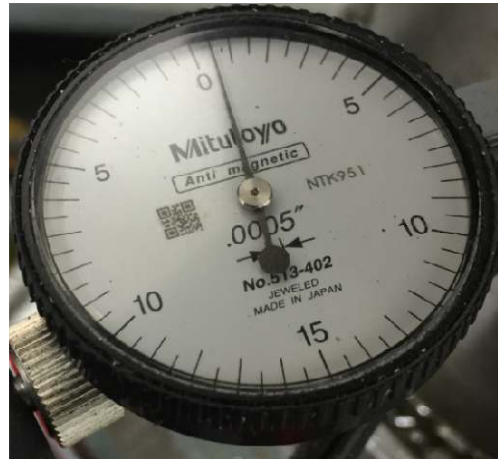
## Test 3

The DTI is supported by the table. The finger is touching the column 16.5" above the base casting.

The DTI showed a forward motion of 0.0005"

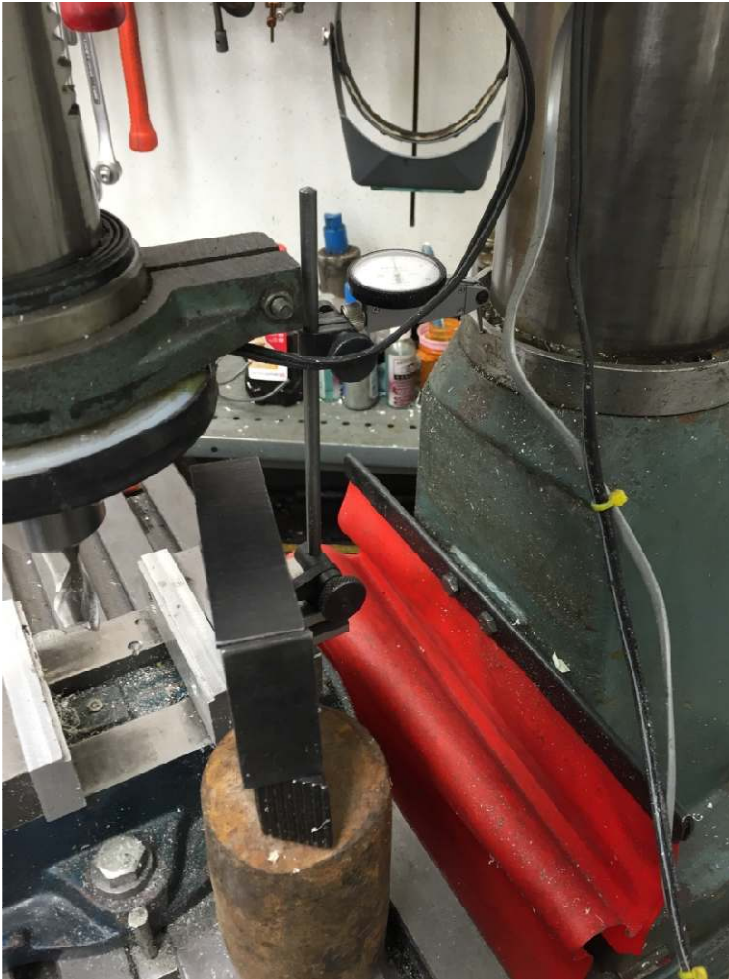
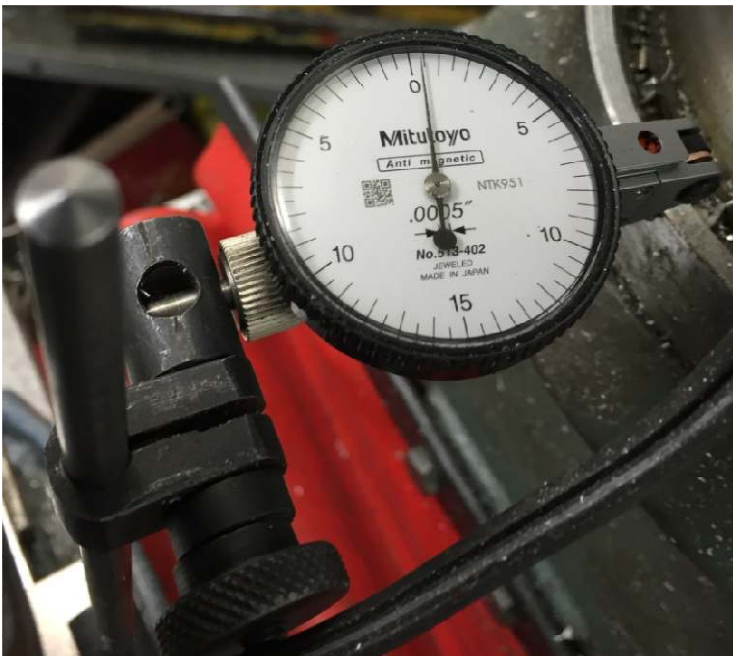
## Test 4

The DTI is supported by the table and the finger is touching the top of the ring marking the bottom of the round part of the column.

I measured a forward movement of 0.00045

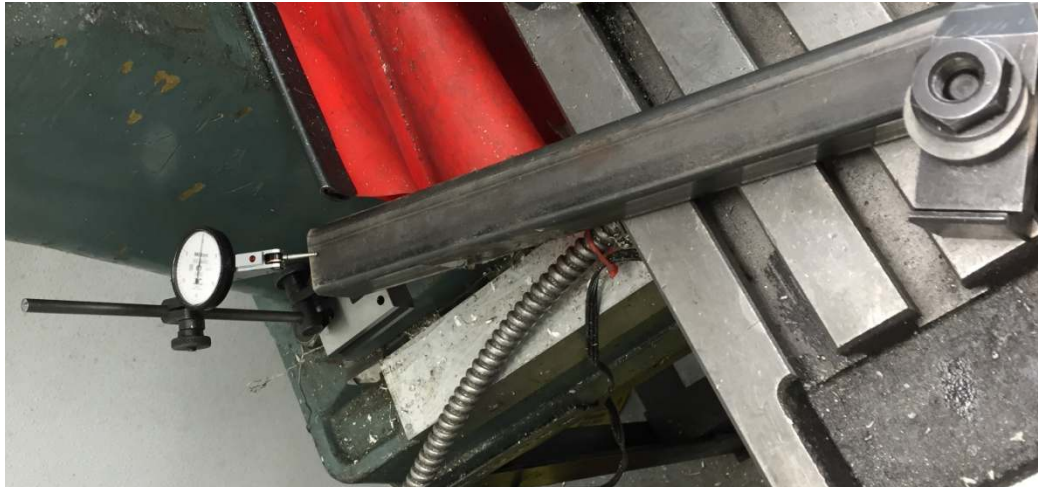
## Test 5

A bar was secured to the table. The DTI is supported by the bottom flange of the column casting. The DTI finger rests on the top of the bar.

No movement of the DTI was observed.

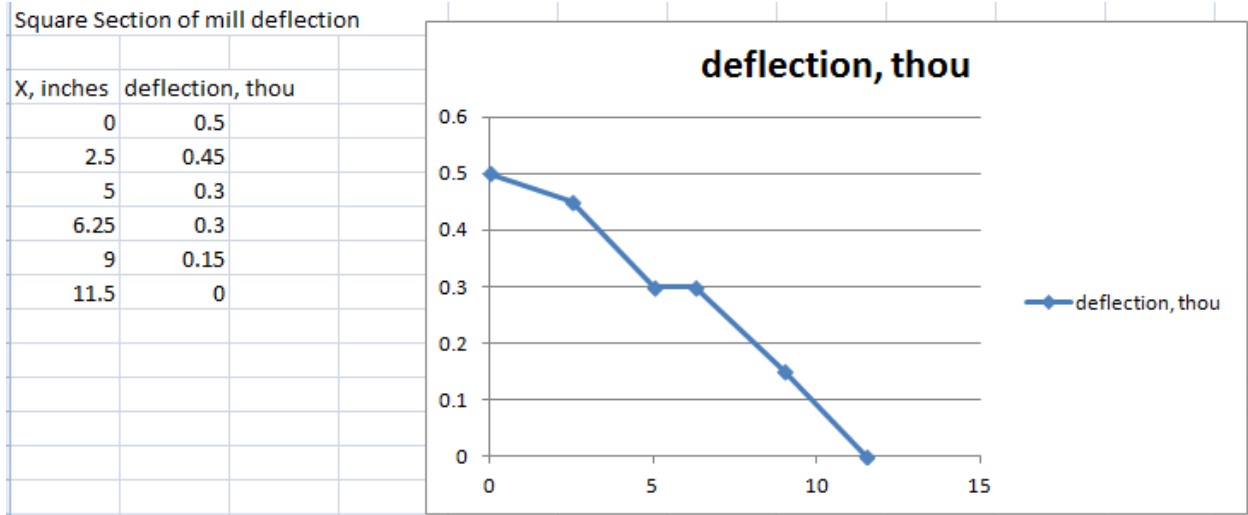
I measured deflection down the rectangular part of the column. X = 0 is at the center of the transition ring between round and rectangular. X = 11.5" is the top of the base flange.

Note that the graph is almost a straight line. This tells me the deflection in the rectangular part of the column is uniform and nothing is broken.

The bottom of the column casting bolts to the base which has a square hole in it. It is possible that clamping a plate across this hole might reduce deflection if the root cause is the weakness of an open box construction.
