# Assessment of My Gingery Shaper's Accuracy

By **R. G. Sparber**

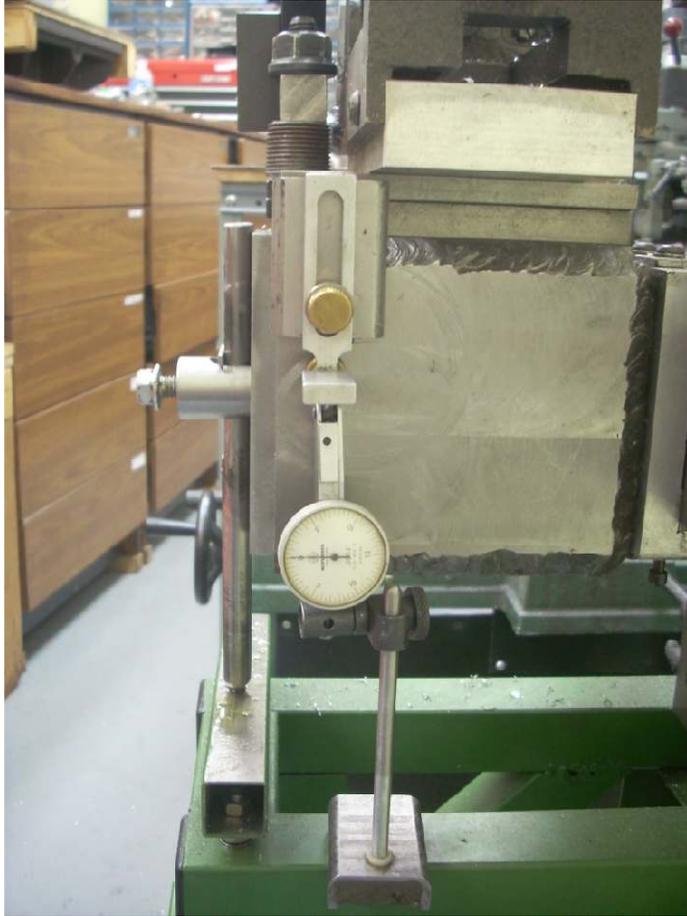
was off by about 0.003". Note that the side to side error on the front is of the same polarity as on the back. So the surface is lower on the right side by around 0.0001" to 0.0002" and front to back I am lower in the front by 0.003".

The first thing I checked was if the table was flexing. It was easy to place my finger against both the front support rod and the horizontal support and feel movement during cutting. I tracked this problem down to burrs on the rod caused by the locking bolt. I added a strip of aluminum between bolt and rod. The burrs on the rod were also ground off.

It now felt much more solid. I then put on my Dial Test Indicator to see just how solid it was. With a lot of pushing down, the needle deflected 0.0005". That should help.

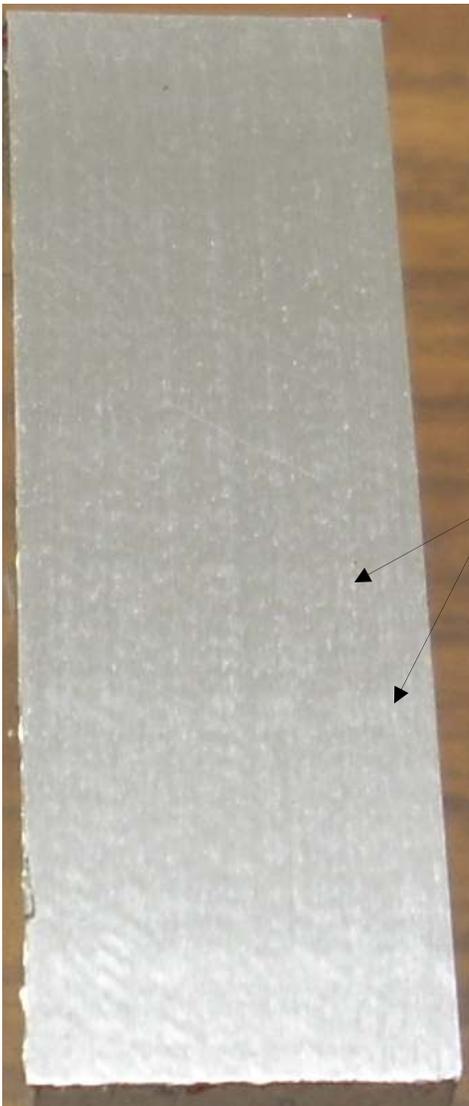
The cutter starts its stroke below the bottom of this picture and exits the top.

As a crude reference, I placed a surface identical to this on a sheet of 600 emery paper. Then I moved the surface about 4" over the paper 60 times and got a mirror finish. The roughness that can be seen in this magnified picture is difficult for me to feel.

If you look closely, you will see horizontal ripples. They are spaced about 0.1" apart. I saw and heard no chatter.

I tried having more overhand on the cutter and also less. It made no difference. Adding weight to the head also made no difference.

I changed to a cutter suggested by people on the shaper BBS and it greatly improved the finish.

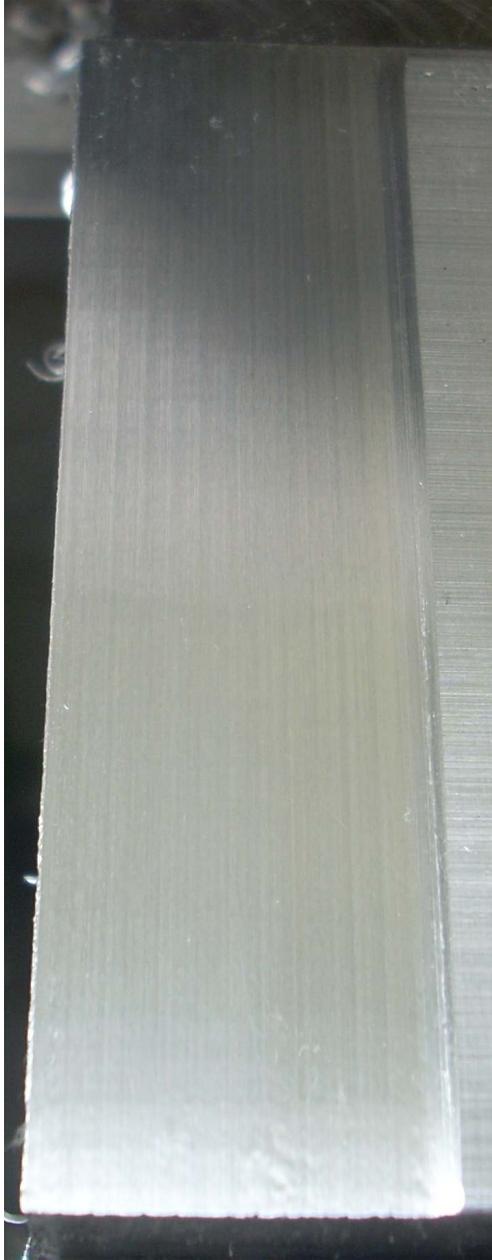
This sample on the left was cut with the ram ways much tighter, a new slide block made of aluminum (the old one was Delron), and the test block is clamped down to the table without a vise.

This sample on the left does look a little better, I guess.

The sample on the right is a copy of the picture from the previous page.
