# New Life for my Beloved Drill Doctor, version 1.0

By R. G. Sparber

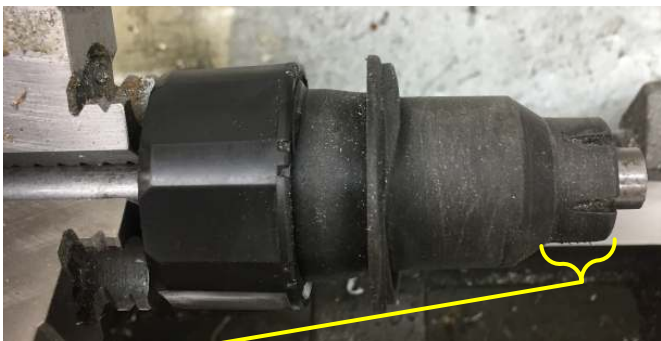
drill and tightened down, I could not fully install the collet. Upon closer inspection I found that the force of the collet fingers over the years had slightly expanded the outside diameter at the jaw end. Steel collet fingers and plastic or hard rubber collet. Hmm.

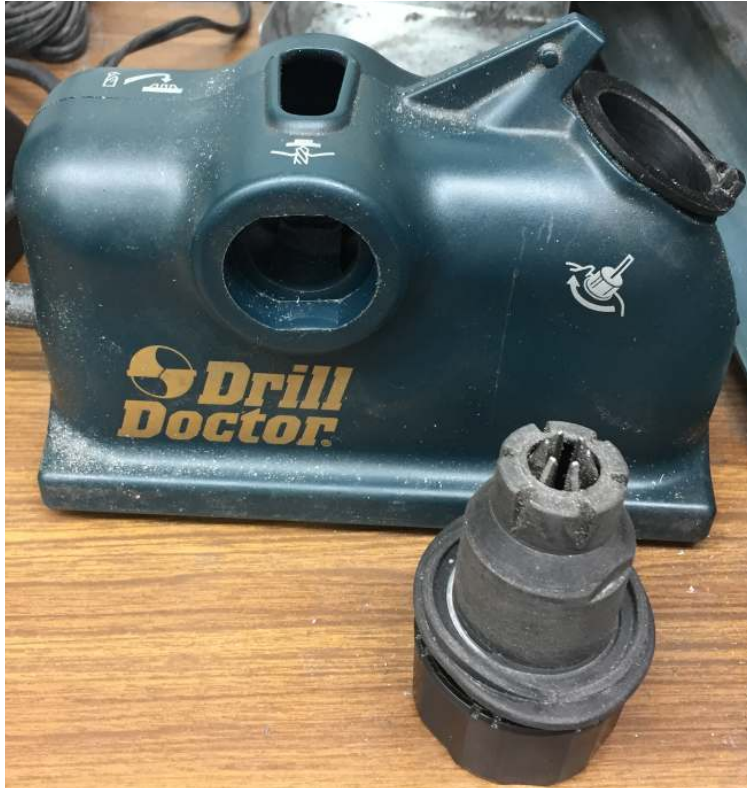
I probably reduced the outside diameter by 0.005" and this has weakened the collet a little. My guess is that the jaw end will expand over time and I won't be able to use this trick again.

I installed a short length of 1/2" drill rod in the collet, locked it down tight, and used the rod to mount the assembly on my lathe.

Then, using a very sharp cutter and high RPM, I took a light cut over just

the jaw part of the collet. After each pass I test fit it to the Drill Doctor. When I achieved a sliding fit similar to when it was new, I stopped.
