Repairing A “Non-Repairable” Door Closer, Version 1.0

By **R. G. Sparber**

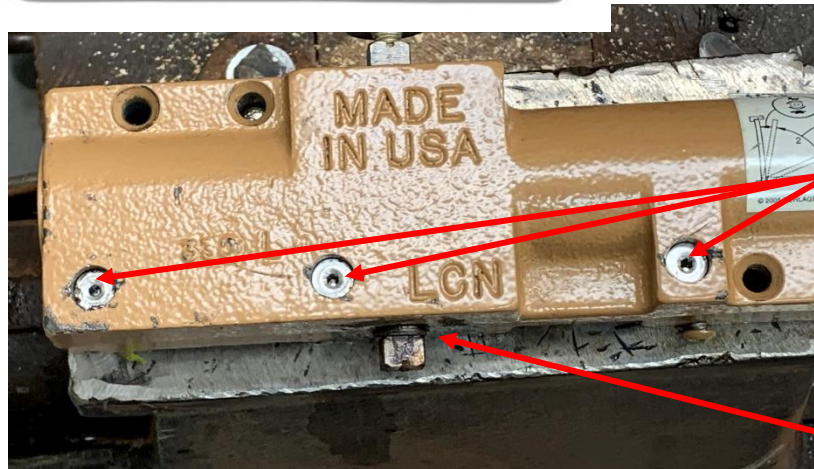
After over 20 years of constant use, it leaked out all of its oil. Is this end-of-life? Not in my book!

Most of the oil leaked from the three adjustment stems.

A small amount of oil leaked from around the pinion gear shaft.

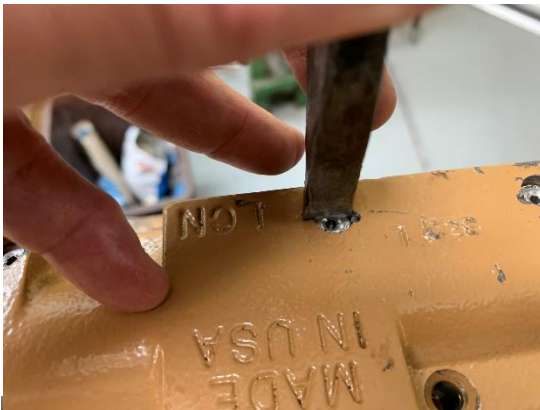
Each stem screws in or out to regulate oil flow. There is a hex recess in the center.

The manufacturer has staked the stems so the user cannot completely unscrew them, pouring oil onto their shoes.

Moving the staked metal away from each stem was possible using a thin drift. I extracted each stem using a box cutter under its lip while turning it with an Allen wrench.

Replacing the leaking O-rings² took a few seconds.

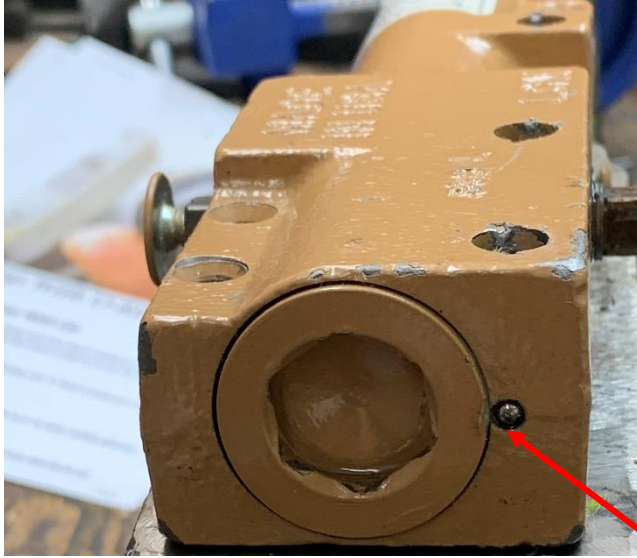
Next up was replacing the O-rings on the pinion gear shaft. Piece of cake – the hex nut is easy to reach.

Oh, was I wrong! It would not budge. I gave up on my wrench and went with a drift and large ball-peen hammer. Nope. Maybe it was a left-hand thread. Nope.

I concluded that the manufacturer won this round. I bet it was a close-fitting thread, and they used a thermal fit: By heating the body and cooling the threaded plug, the plug could be screwed into place. As the temperature equalized, the bore shrunk, and the plug expanded, permanently locking in the plug.

Heating the body might loosen the plug but given that there was still some flammable hydraulic fluid inside, this was not a good idea. Oh well, I'll have to live with this small leak.
