Repairing a 1-Ton Arbor Press, Version 1.0

By **R. G. Sparber**

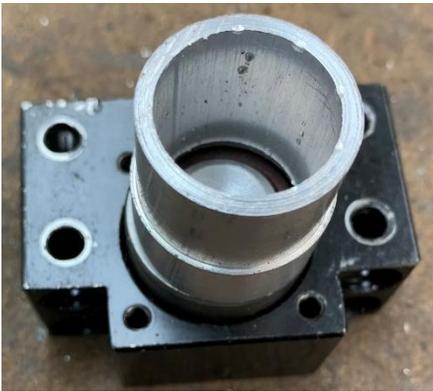
I pressed out a bearing from this block yesterday, and it went well. The trick is first to heat the aluminum block with a hot air gun. My 1-ton arbor press pushed it out with a gentle push on my 2-foot-long cheater bar.

This time was a bit different. I pushed harder until I heard a clunk. Looking at the bearing, I could see that it was unaffected. WTF?

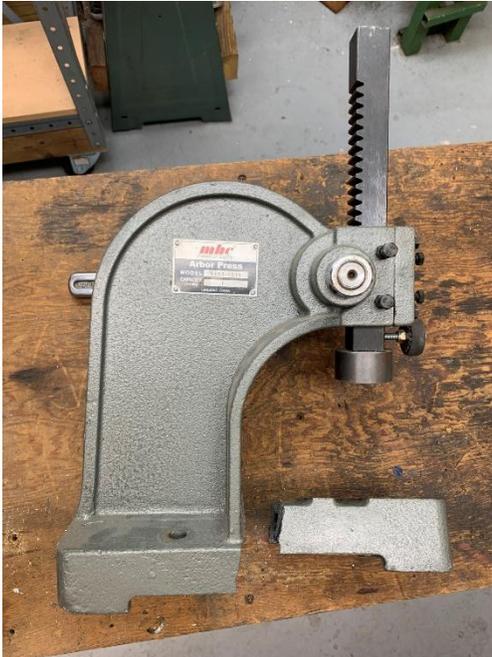
That clunk was my arbor press transforming from one piece to two.

It took me a moment to realize that the press was lifting up on the area that failed. Cast iron is weak in tension.

I do not have the skill or equipment to weld cast iron. Brazing takes more heat than I can generate from my handheld MAPP torch. Even if the weld or braze held, the original problem of cast iron in tension remained. Buy a new press? The price has gone way up, but the quality is, at best, the same.

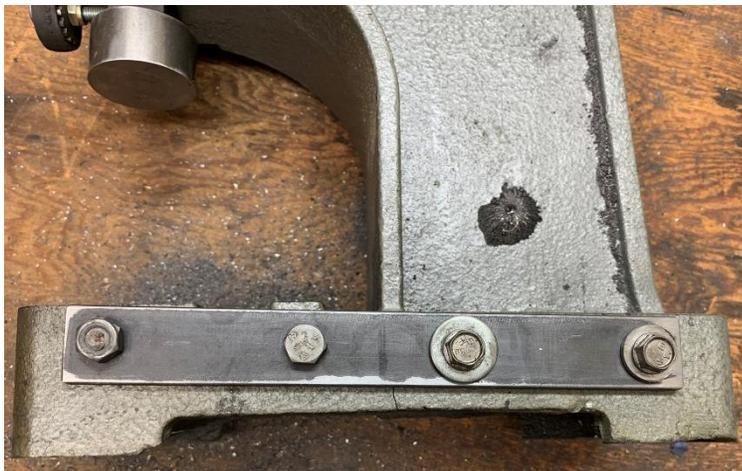
A lesson learned: check to see what is in the casting before locating the mounting holes. One of the holes grazed the underside of the top, preventing the tap from going through.

I also wish I had lowered the bar down a bit so I could add steel nuts. The threads in cast iron aren't that strong.

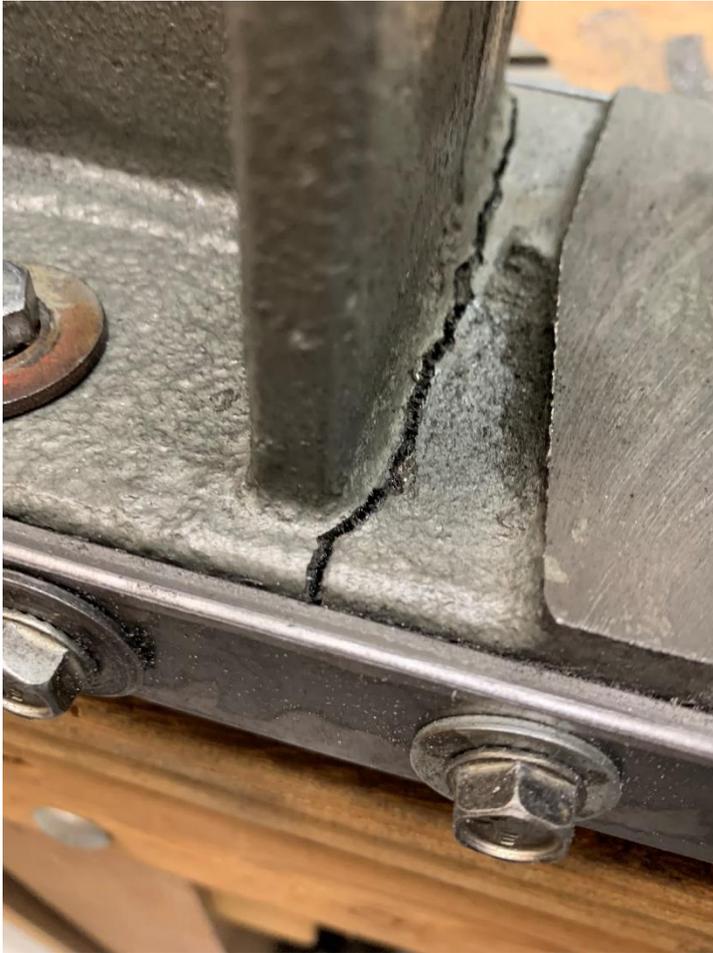
I torqued down on all bolts and then applied about as much pressure to my cheater bar as caused the failure.

The repair held, but the rear casting did lift a little. Upon closer inspection, I found one bolt not fully tightened.

I repeated the test, and the casting did not shift.

My press is not as good as new because that crack is still there. However, I believe the press can take a full load.

If I had added these bars, with nuts on the ends of the bolts, before the failure, I could say it is better than new.
