Ram Stroke Adjustment

By R.G. Sparber

10/18/2008

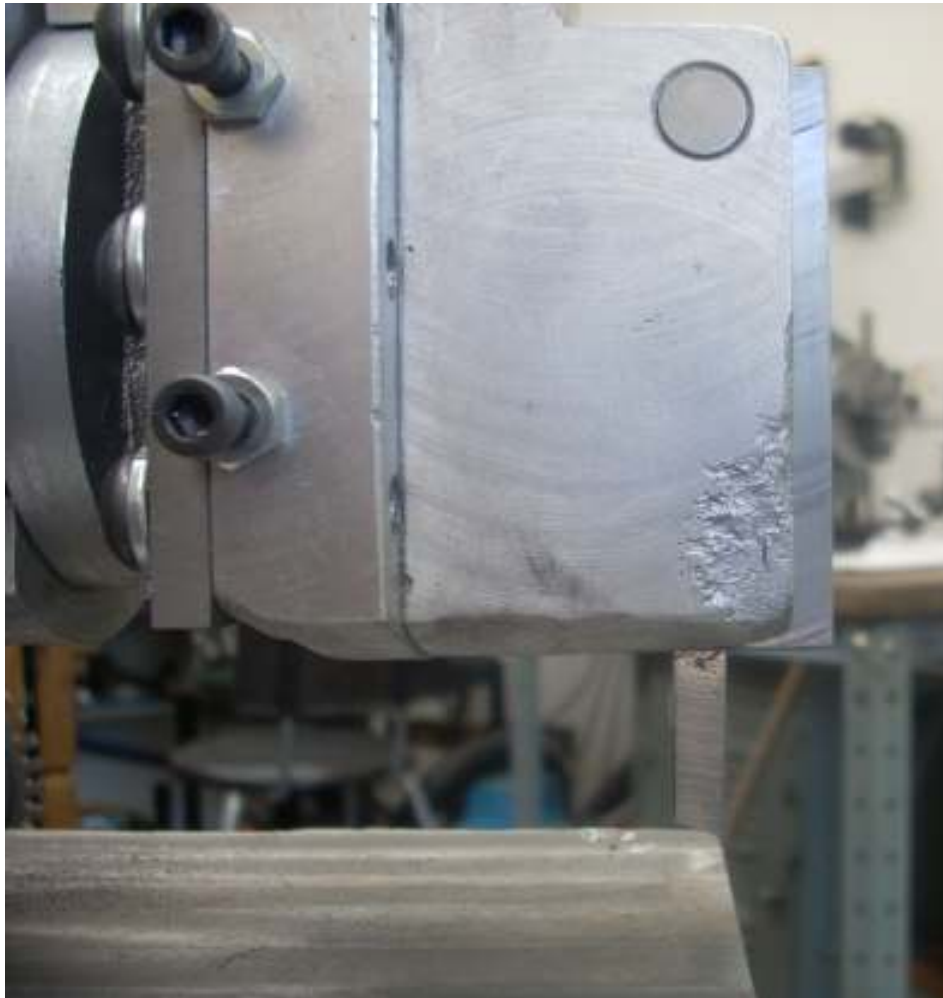
One of the challenges of modifying Gingery's shaper design is that there are unexpected consequences. One of these surprises was that the cutter did not reach far enough forward. It also started too far back.

The main reason for the original misalignment is how I modified the clapper. The cutter is set back such that the center of the cutter lines up with the center of the pivot pin. This is supposed to reduce chatter.

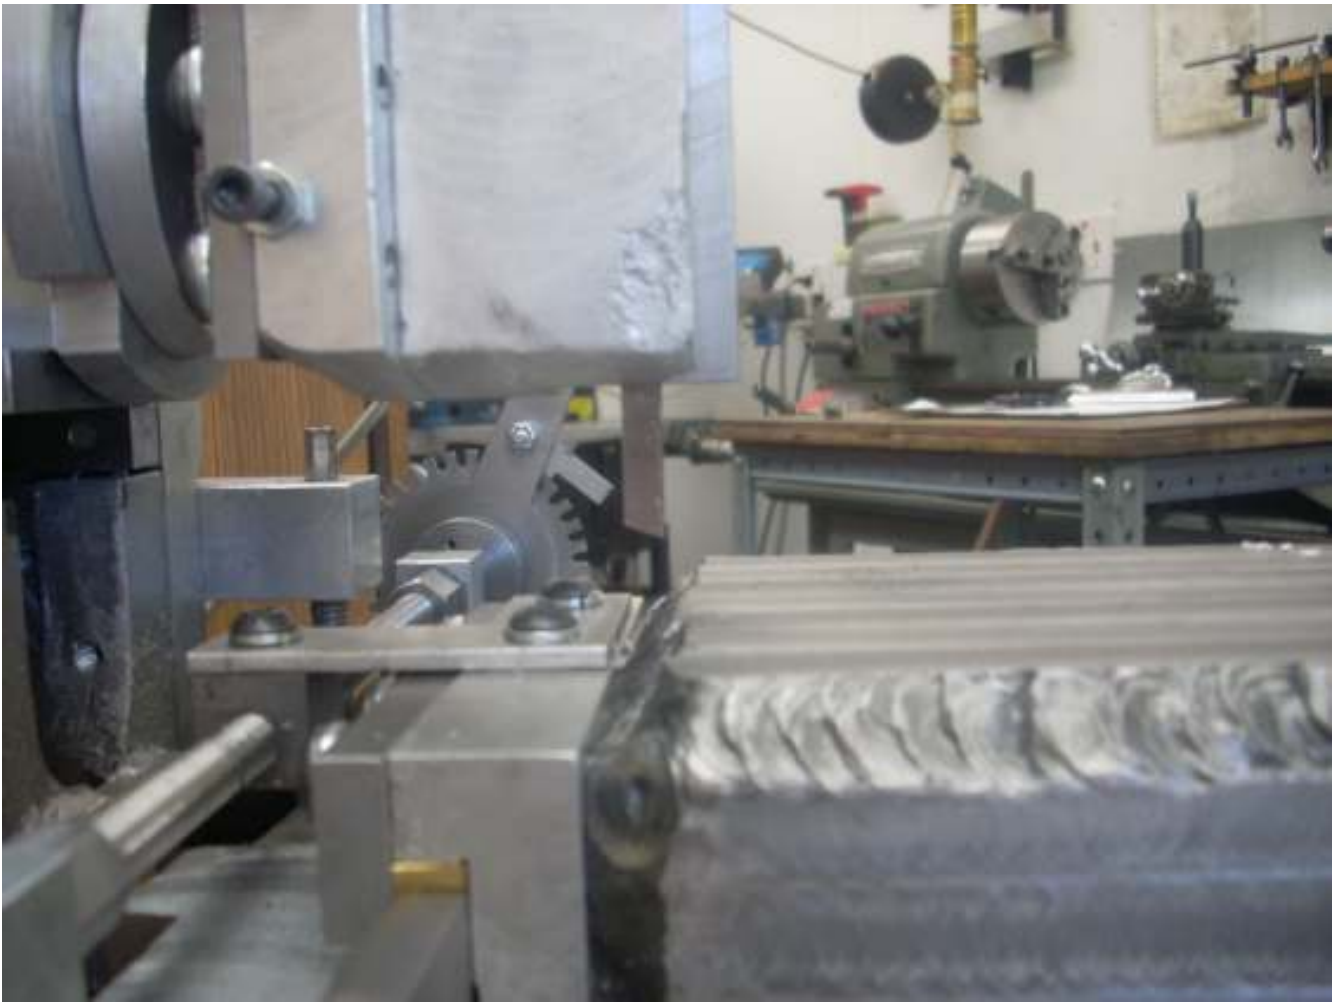
After making a few modifications, I was able to get the cutter to almost reach the front edge of the table.

At the start of the stroke it now just comes off the table.

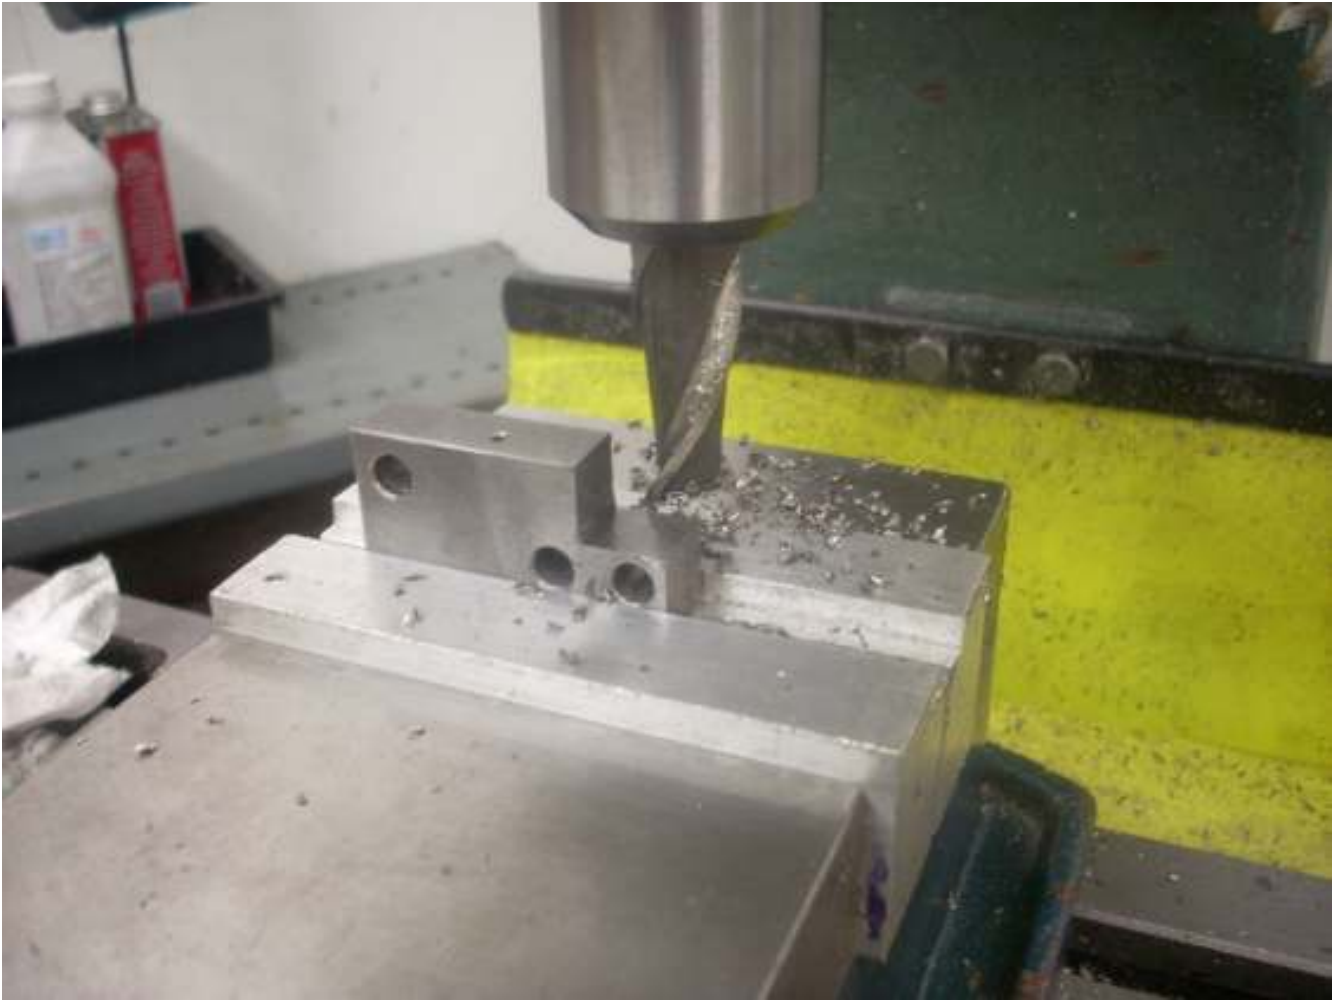
One point of interference is the link to the ramp clamp. Here I am cutting a step so the ram clamp can have a bit more room.

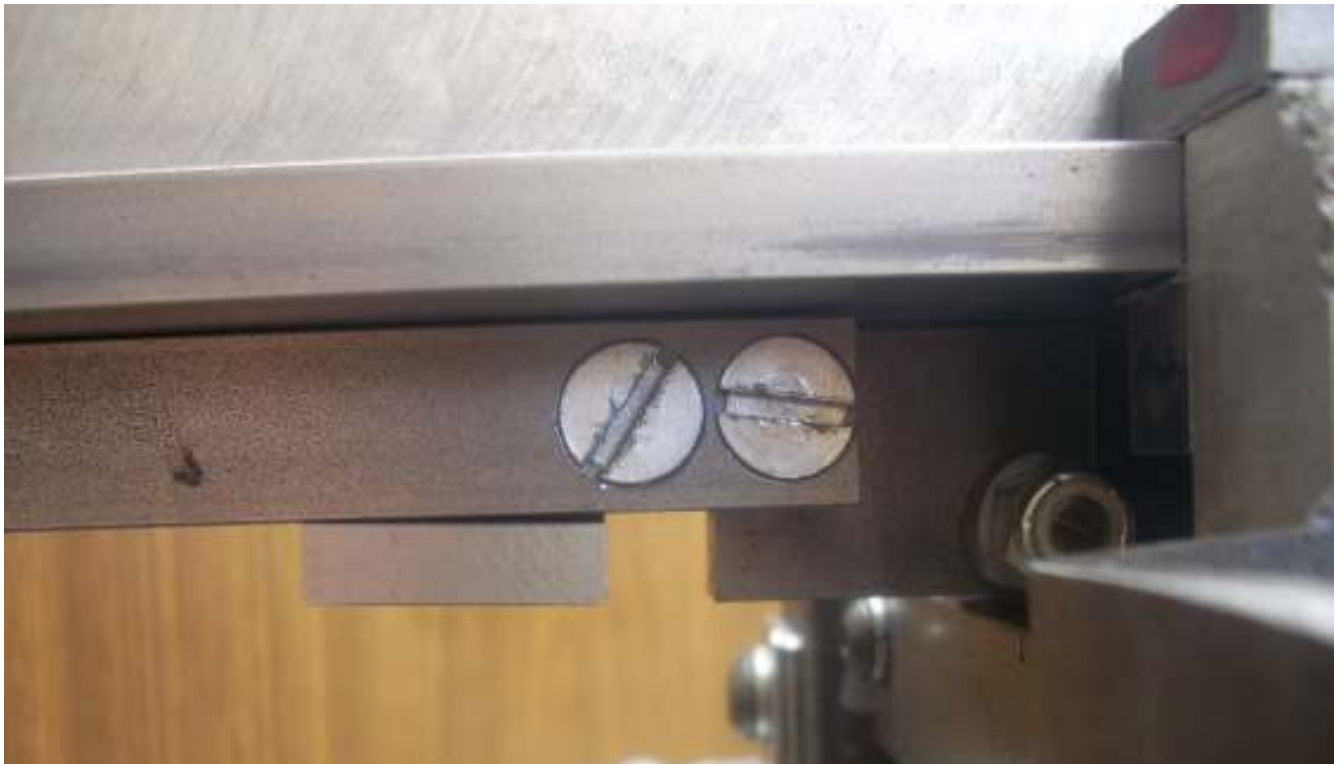
Gee, that should have helped but now I see that the clamp guide is hitting.

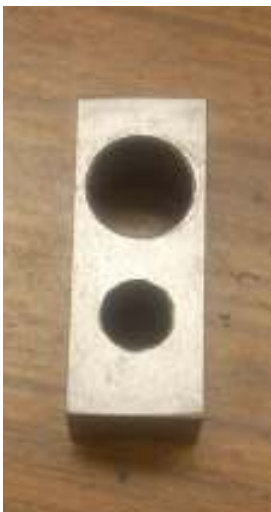
The large hole passes the ram clamp while the smaller hole is for a screw that fastens it to the bottom of the ram (see page 67 of Gingery's book). By just removing the screw and rotating the block, I was able to gain over $\frac{1}{2}$ ".

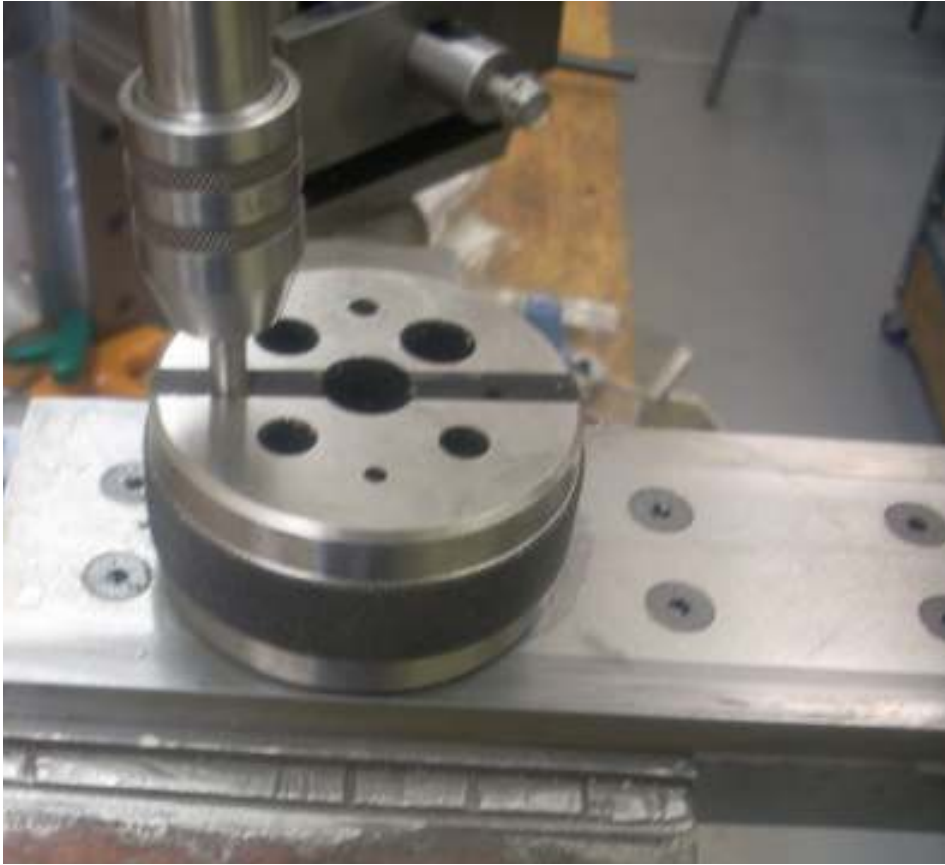
Here I am using a bench block to tap the new hole in the ram ways for the clamp guide screw.

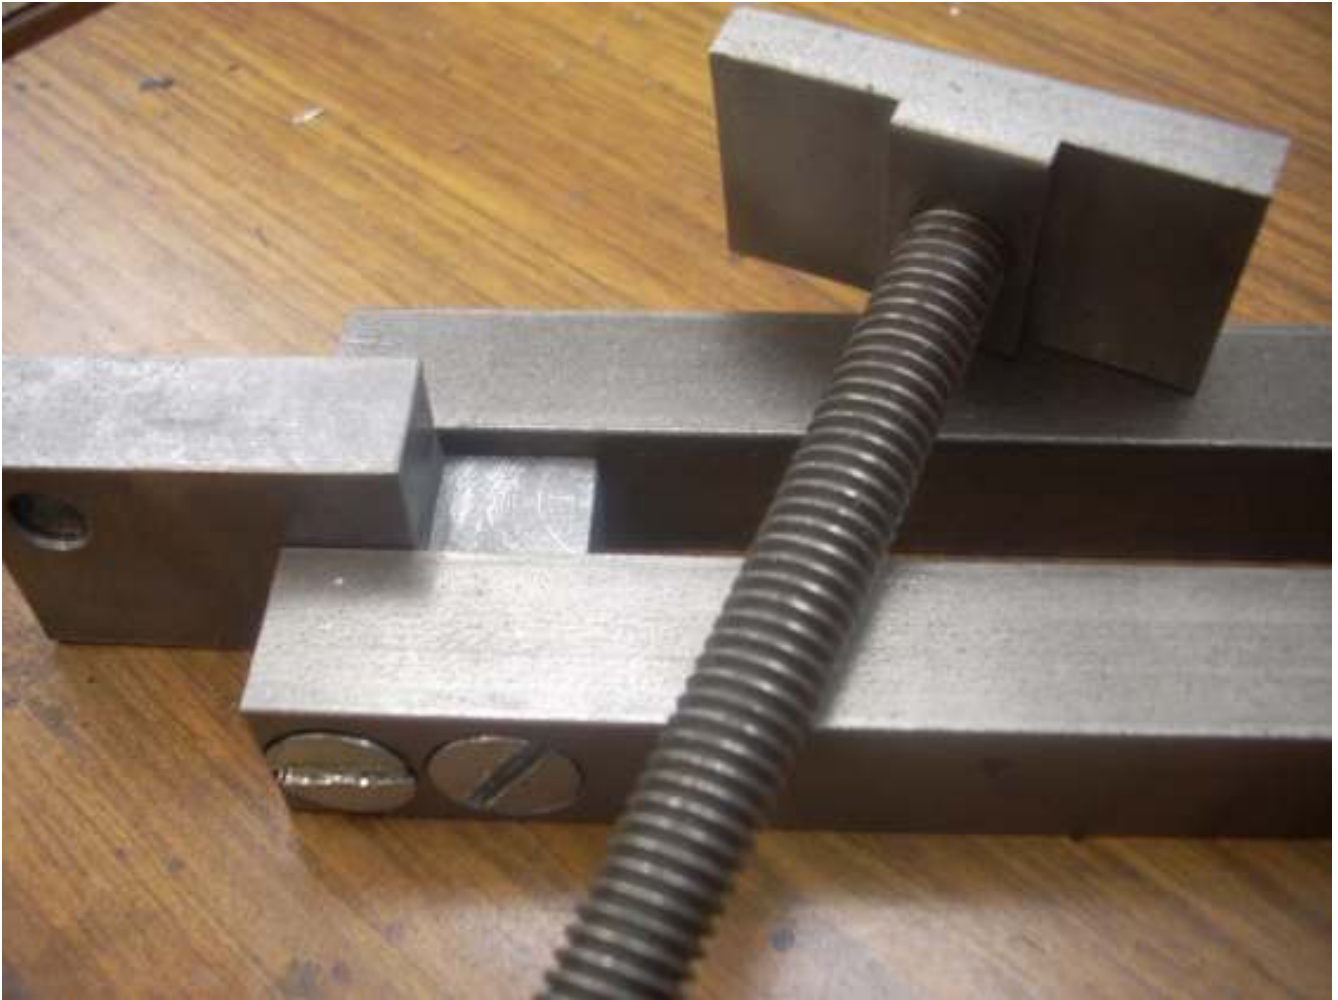
I had to recut the link block so that the raised part of the clamp would slide over the link.

I also had to recut the clamp guide so the larger hole was open on the end facing the link. That got me another 0.2”.

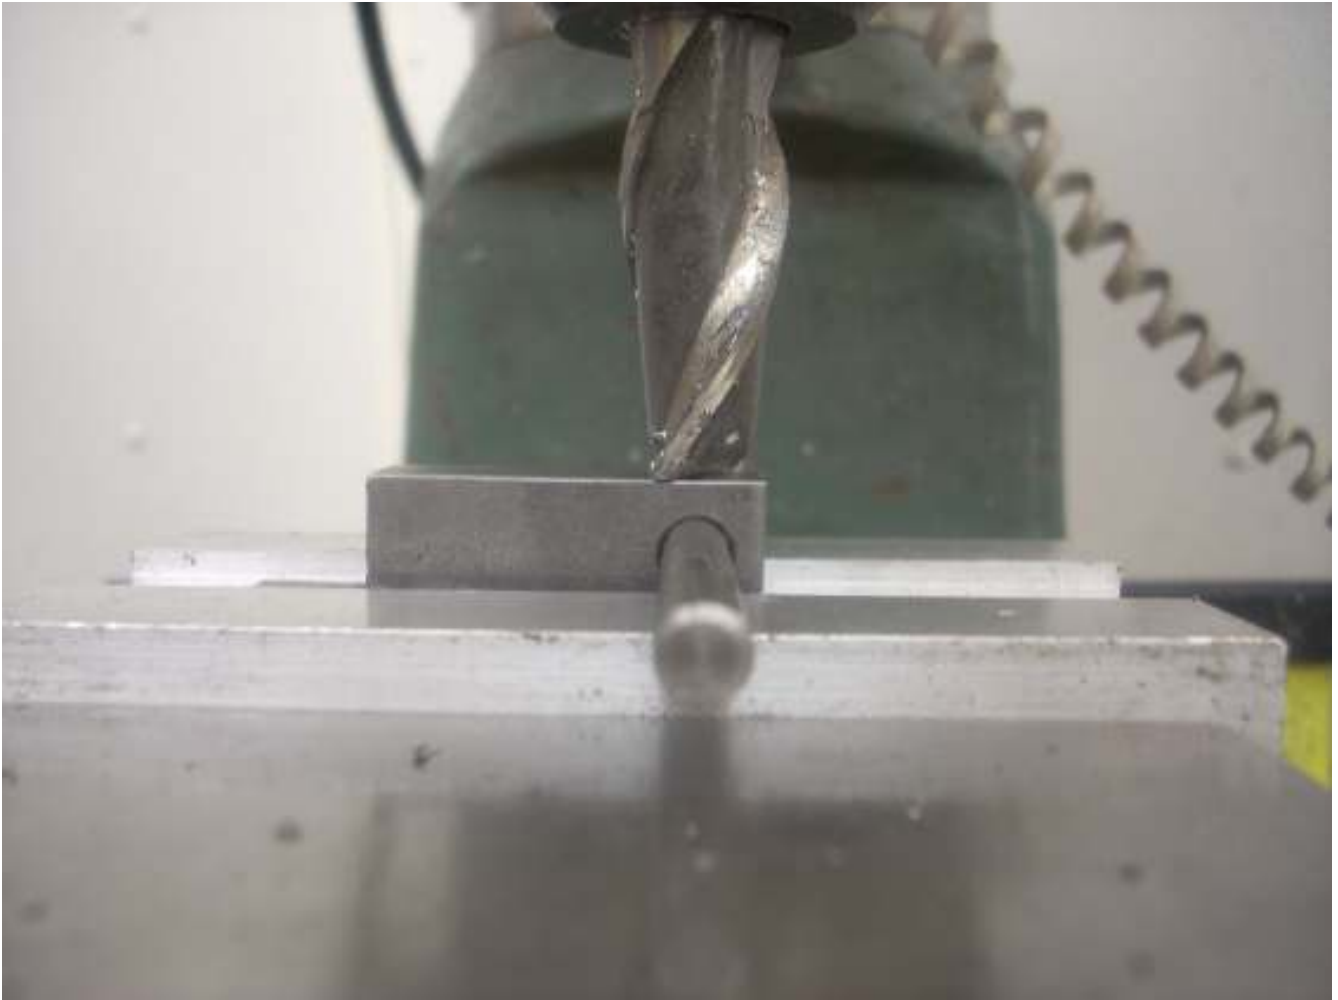
As a final step, I decided to round the corner of the link block to make it easier to move around the scotch yoke's closest corner. I started by running a close fitting rod through the hole and having it rest on the jaws of my vise. The cutter is then lowered until it rests on the top face. The DRO is then set to zero. I now know how much to feed in to get the proper radius which will blend into the top face.

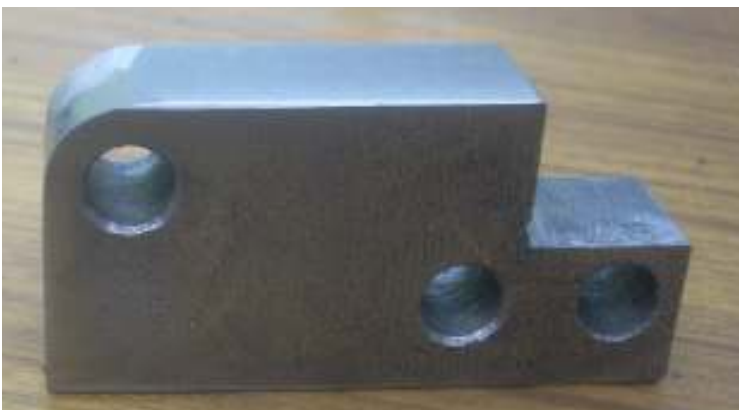
The block was then rotate so the top right corner points straight up. I milled it down until the DRO read zero.

This turned out to be enough metal removed so I moved over to the belt sander for a final rounding.
