Variable Frequency Drive Noise Reduction, Version 2.1

By R. G. Sparber

Conclusion

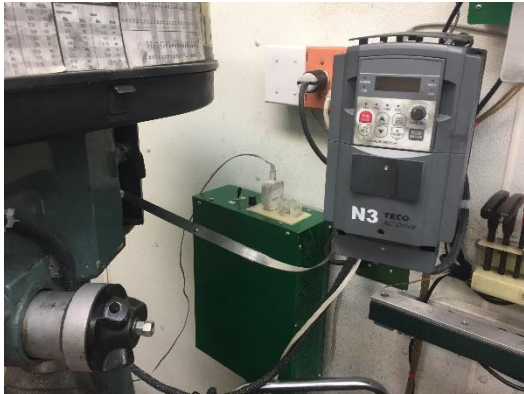
What could be simpler? We have a transmitter and we have one or more receivers. If the transmitter is your local radio station and your receiver is the radio in your home, that is simple to understand. The transmitter sends a signal and your radio receives it.

But what if the receiver is one or more computers driving your CNC system and the transmitter is probably related to the spindle motor? Well, it does it some of the time but not instantly. Not so simple to figure out. And you can't just leave the spindle motor off.

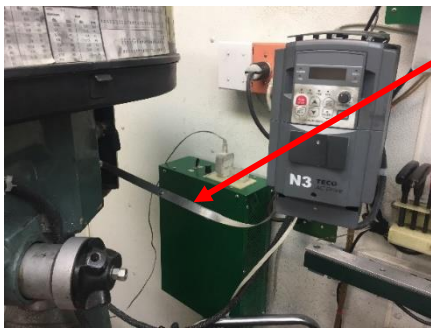
Here is my quick and dirty temporary fix. I ran a strip of sheet metal between the VFD and a mounting bolt on the motor. Without the strip, an error would halt program execution within 30 seconds. Preceding this failure was a continuous stream of corrupted data between the CNCPC and the Acorn (Thanks to Marty for showing me these messages). With this connection, There was no corrupted data reported.

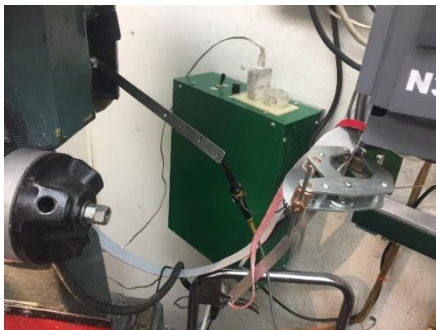
I then experimented with ribbon cable. Picture very fine wires encased in insulation all running along parallel paths. At the ends, these fine wires were soldered together. This too eliminated program execution errors.

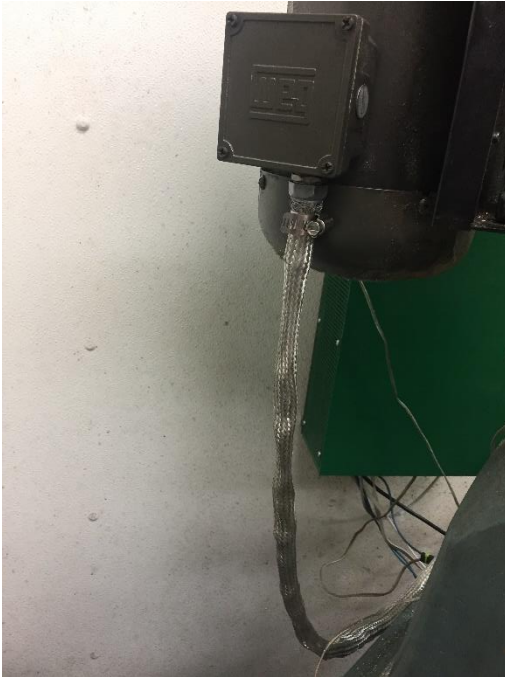
At the motor end, I was able to use a standard conduit coupler and a short length of conduit. The tubing slid over the conduit and was secured with a hose clamp. Ah, but there is more to this story.

My motor was designed to be sealed. This was done with a rubber gasket between access door and box plus between box and the body of the motor. Great for keeping out contaminants. Awful for high frequency noise suppression.

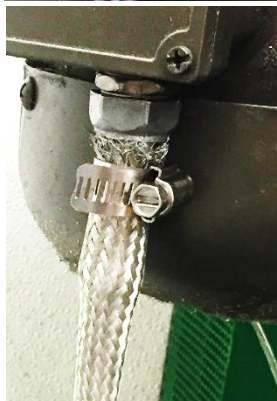
I ground off the paint under the box.

With the box now in direct contact with the motor housing, my braided copper tubing has a low inductance connection.

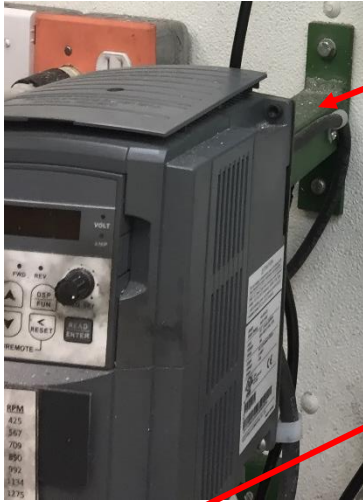
It didn't take long to discover that the VFD support arm was not connected to ground. Sure there were 4 bolts passing through the VFD mounting ears and into the support arm plate, but the VFD case is plastic.

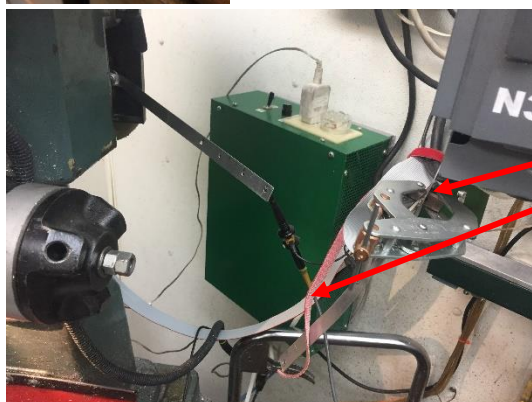
The ribbon was clamped to VFD ground and dressed along the motor cable.

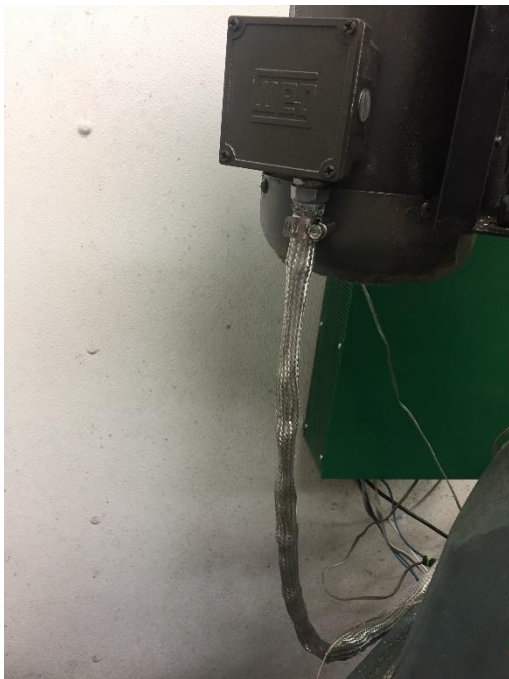
Testing the woven copper tubing turned out to be inconclusive. Sure, the CNC system was stable, but I found no way to measure how close we were from a failure.
