CPAP Mask Holder Repair

By R. G. Sparber

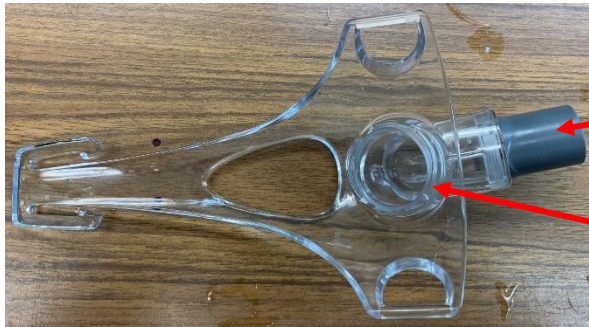
One of those parts is the mask holder. An airline connects to the grey cylinder on the right.

A pivoting coupler snaps into the mask.

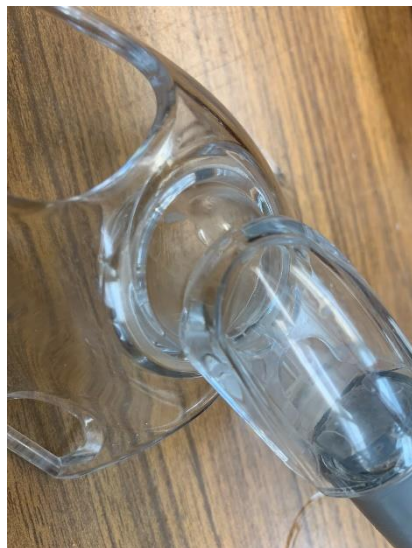
This holder is considered worn out when air leaks around this pivoting coupler.

The plastic in the frame has relaxed enough to allow for a gap in the ball section.

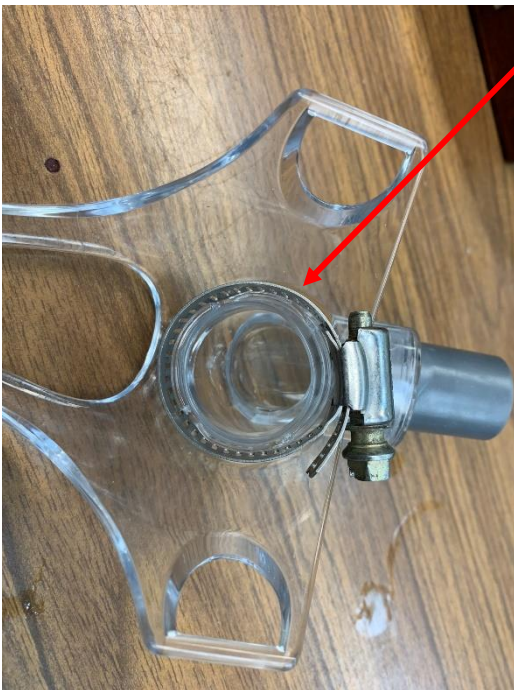
I tightened a hose clamp around the flange and warmed the plastic with my hot air gun. Then I quickly cooled it with a spray of distilled water.

Now the ball is again a tight sliding fit in the socket.
