Repairing A Jammed Telescoping Step Ladder, Version 1.0

By R. G. Sparber

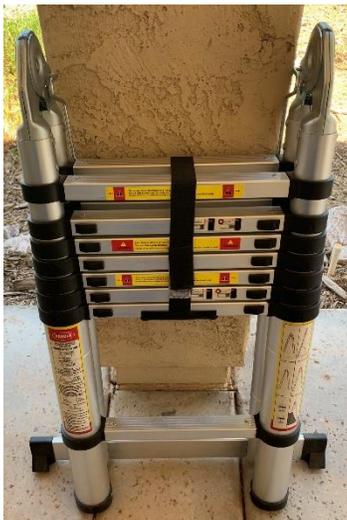
Then I saw some aluminum tubes sticking out. Ah, scrap metal! As I opened the lid and gingerly removed the smelly bag of garbage on top, I saw this telescoping step ladder. They cost about \$140 new². Since I was looking at scrap metal, I didn't care if it worked or not.

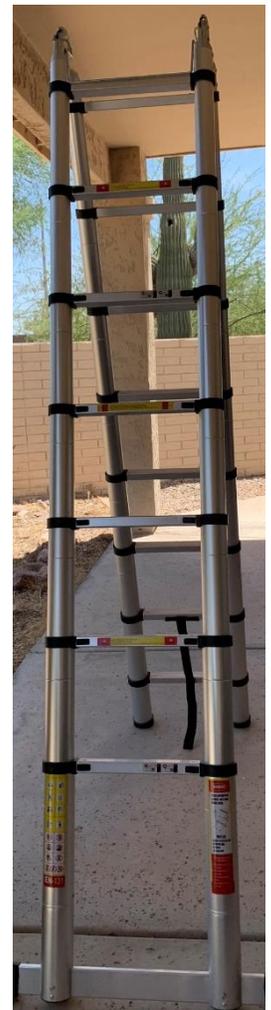
It took me a while to figure out that those tiny dents in the pipe were causing the binding. Someone had innocently rested the ladder against a sharp corner and dented it in ever so slightly. Given the close tolerance of these telescoping sections, that was enough. Lesson learned.
