What's Inside a Lectric XP eBike Battery?

Version 1.1

By **R. G. Sparber**

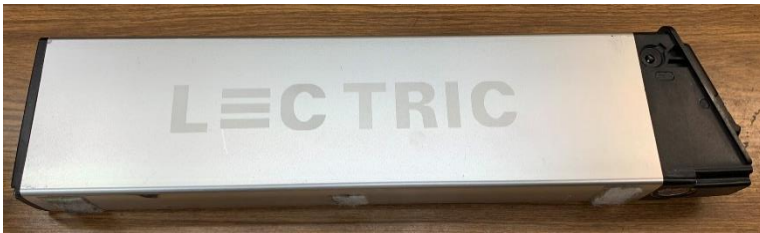
The capacity of my Lectric XP 1.0 eBike suddenly went from 10.4 ampere-hours down to around 5. Such a sudden drop hints at a bad cell. Since this battery is beyond the

warranty period and a new one is coming, I decided to find the bad cell, replace it, and have a backup battery.

1. The battery is solidly put together (and a bear to take apart.)
2. The cells are Samsung 18650 29J cells. They are *not* cheap factory rejects.
3. All cells measured 4.1 volts, which is typical of a good cell. I am left with the Battery Management System as a possible culprit.
