Gingery Shaper Surface Tests, version 4

By R. G. Sparber

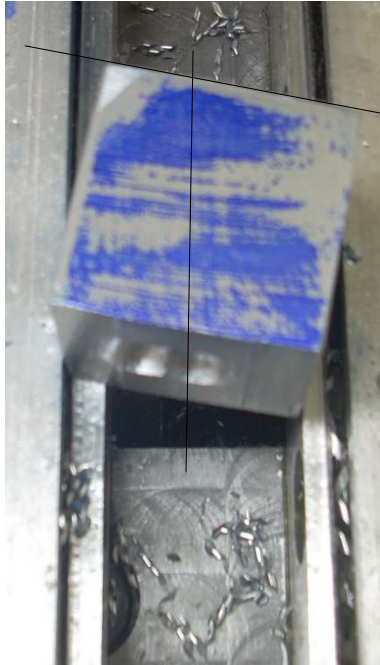
As per John Martin's suggestion, I turned the block so the initial contact of the cutter was not perpendicular to the motion of the ram. It seems that this reduced the ripple. It does appear to me that the ripple is still perpendicular to the ram's motion and not the edge of the block.
