# Assessment of My Gingery Shaper's Accuracy

By **R. G. Sparber**

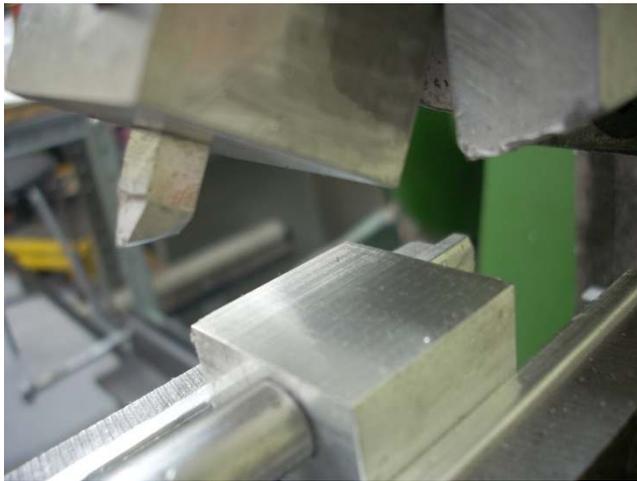
I have owned this shaper for over a year yet never seriously looked at its accuracy. Thanks to a prod from “Wonk” on gingery\_machines, I got to work.

The technique I have used so far is to cut a 1” block of 6061 aluminum on opposite sides and then check how parallel the faces are with my best mic. In all cases the block is cut on one face, deburred, flipped over such

that it rotates along the axis of the ram, and then the second face is cut. I again deburr and measure it with my wiz bang mic.

On my first run, I zeroed my mic at the bottom left area of the test block and looked at the variation at the other 3 corners. Then I returned to my zero point to verify it was still near zero. I saw:

+0.00345”	+0.00280”
0 and when done, 0.00005”	-0.00015”

This tells me that my front side to side thickness was varying by 0.0002” and my back side to side thickness was only varying by 0.00065”. However, front to back

was off by about 0.003". Note that the side to side error on the front is of the same polarity as on the back. So the surface is lower on the right side by around 0.0001" to 0.0002" and front to back I am lower in the front by 0.003".
