# New Life for my Beloved Drill Doctor, version 1.0

By R. G. Sparber

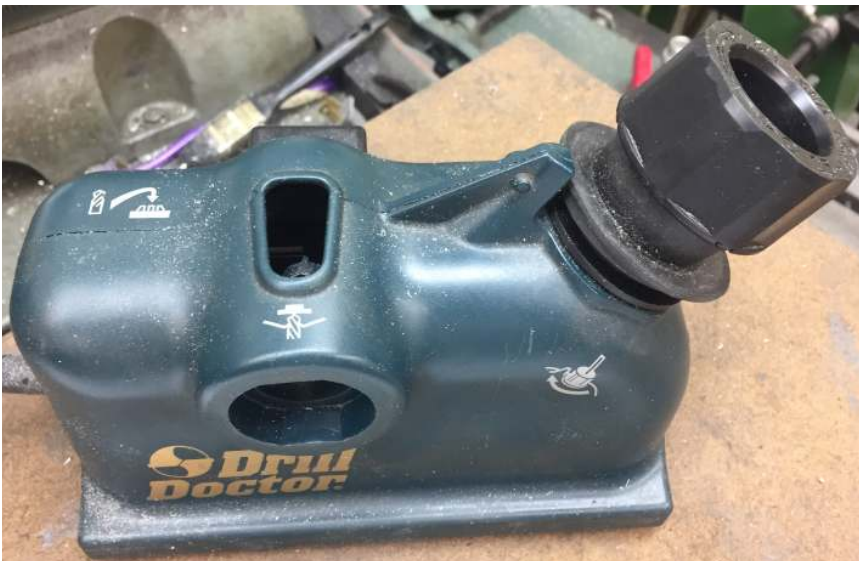
I have owned this Drill Doctor for 16 years and am very happy with it. About 5 years ago I replaced the diamond grinding wheel. Now the collet has become hard to turn. Before I buy a new collet for \$35, is there a way to fix what I have? Nothing to lose.

I found that with no drill in the collet, it turned fairly well in the body. But when I installed a 1/2"

drill and tightened down, I could not fully install the collet. Upon closer inspection I found that the force of the collet fingers over the years had slightly expanded the outside diameter at the jaw end. Steel collet fingers and plastic or hard rubber collet. Hmm.

I installed a short length of 1/2" drill rod in the collet, locked it down tight, and used the rod to mount the assembly on my lathe.

Then, using a very sharp cutter and high RPM, I took a light cut over just

the jaw part of the collet. After each pass I test fit it to the Drill Doctor. When I achieved a sliding fit similar to when it was new, I stopped.
