Repairing A “Non-Repairable” Door Closer, Version 1.0

By **R. G. Sparber**

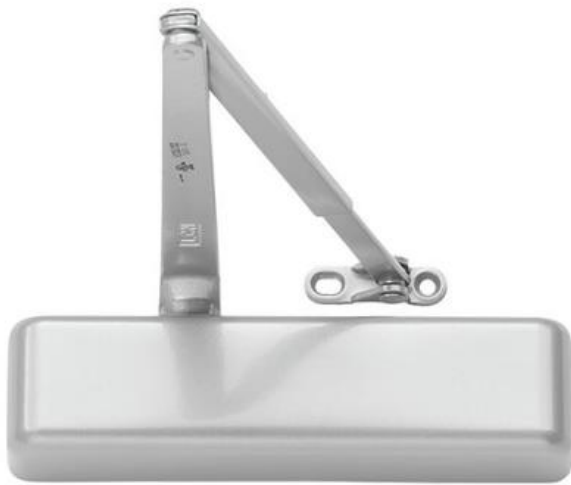
The LCN 4031 commercial-grade door closer is an excellent machine. It better be since it costs almost \$400.

After over 20 years of constant use, it leaked out all of its oil. Is this end-of-life? Not in my book!
