Fitting the Ram to the Column

by R. G. Sparber

02/01/2008

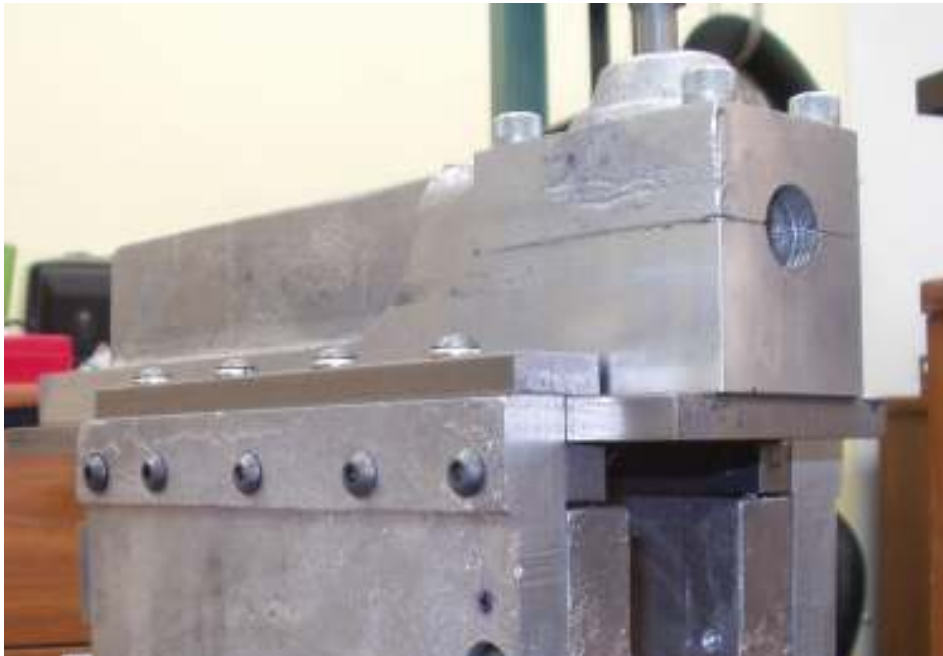
Getting the ram to slide smoothly in its guide takes a bit of effort.

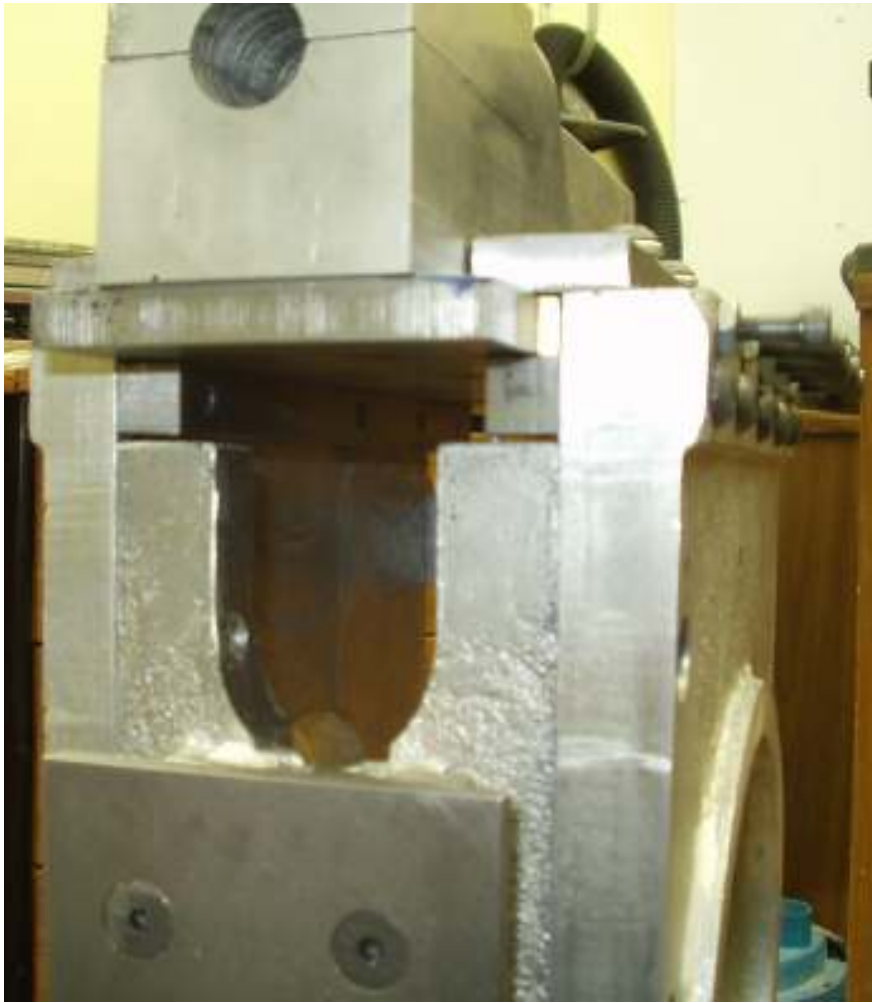
The bottom plate of the ram must be a good sliding fit on four sides. I chose to use UHMW tape over the slide ways and the clamps. The left edge, as viewed facing the front of the machine, is CRS on cast aluminum. I may later change this to UHMW tape.

The right side has the gib which is brass. Adjusting the gib is easy because of the 5 adjustment screws.

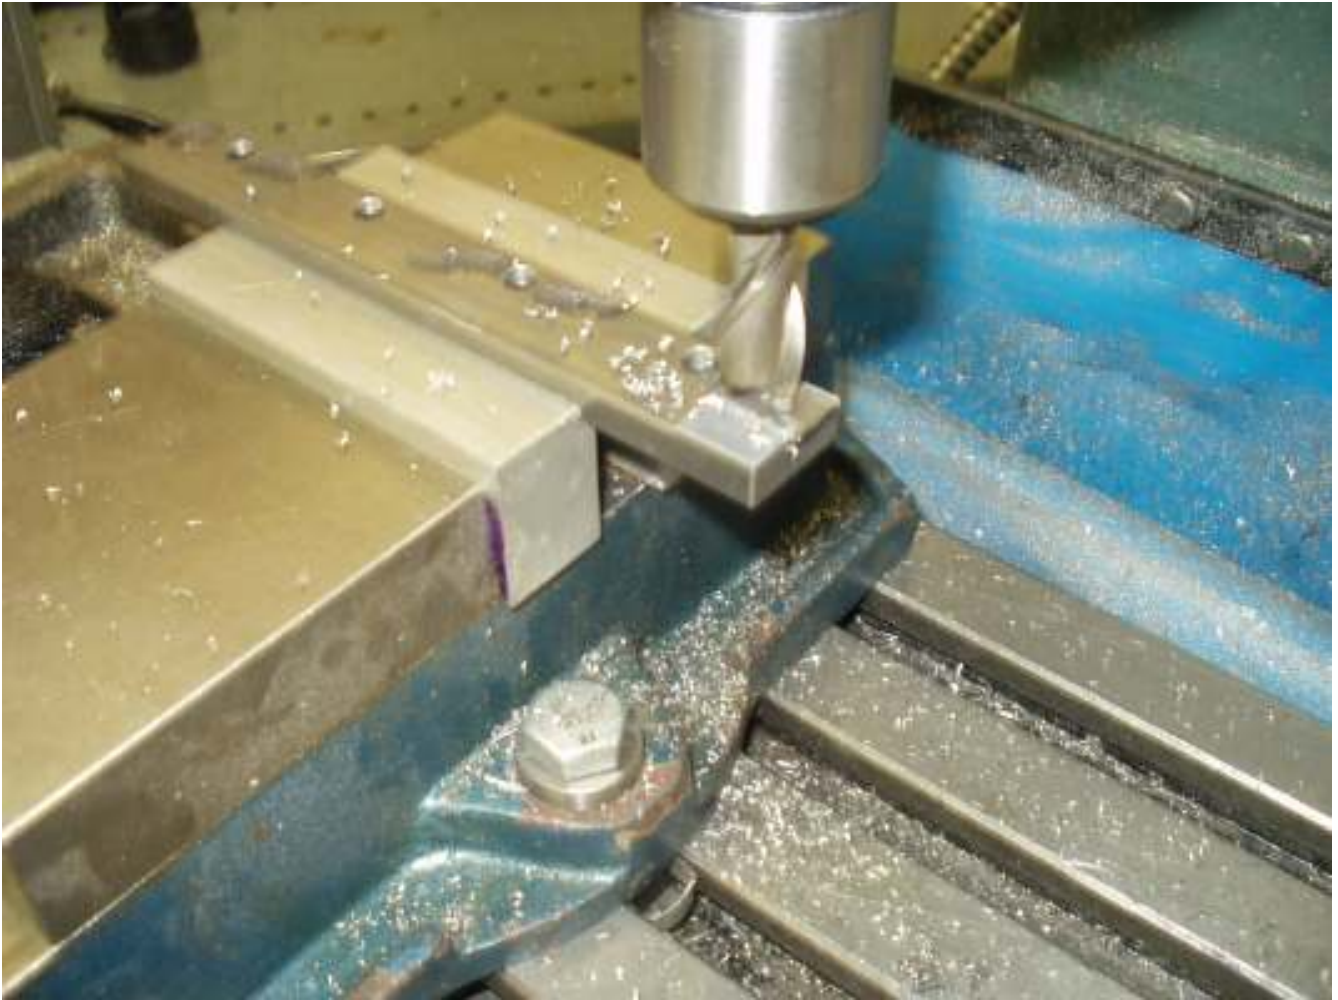
I set my mill vise and took a clean up cut on the soft jaws. My left clamp was then clamped in place. I am about to cut a step 0.025" deep and 0.600" wide. Note the white patch on the right end of the bar. It is a scrap of UHMW tape.

Not to worry. I just modified the clamps. Gingery called for 1/4" CRS but I chose to use 3/8" so the loss of 0.025" of thickness won't matter.

After making this pass, I took about 0.001" off of the 0.400" pad in order to guarantee that the two faces are true.

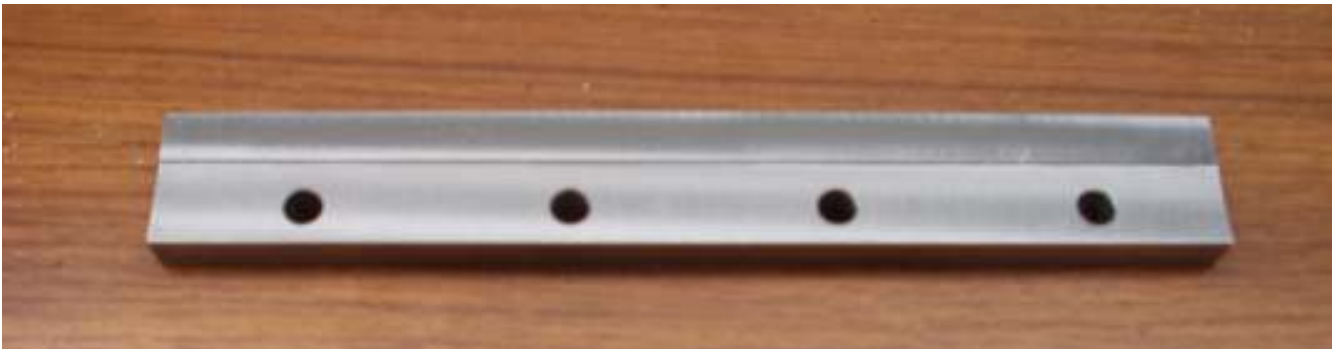
Here is the finished piece.

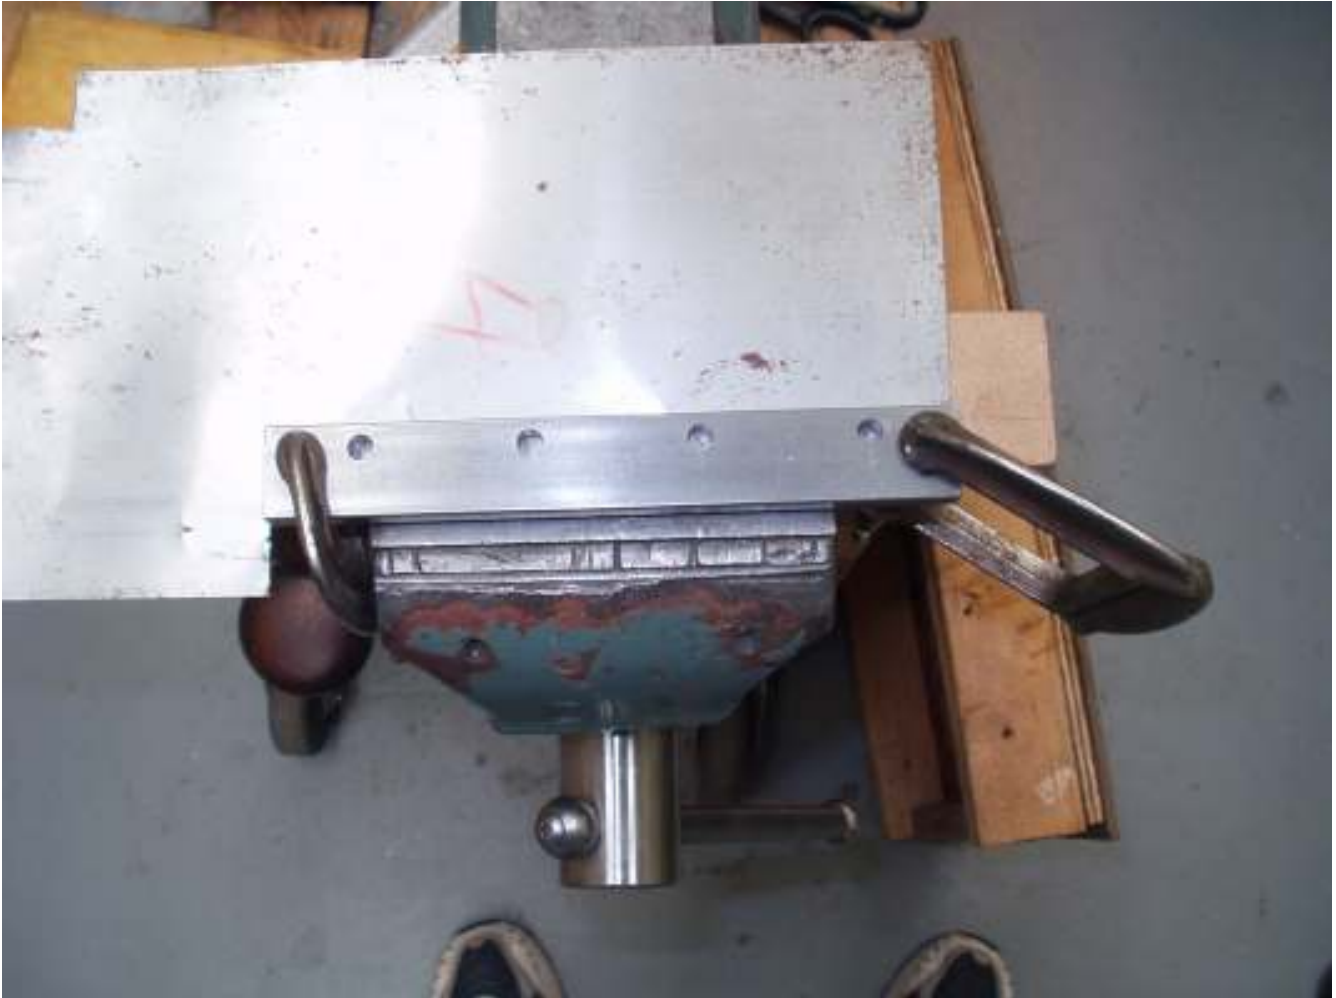
I was lucky to have cut that step in the clamp bars. It enabled me to clamp a piece of MDF in my bench vise, fit the first clamp bar against a piece of 0.004" shim stock, and clamp down. I then ran my "F" letter drill down each hole, through the shim, and into the MDF. The holes therefore are perfectly aligned and undistorted. Without moving the C-clamps, I used an Exacto knife to cut the shim. After each shim was cut, its orientation was marked.

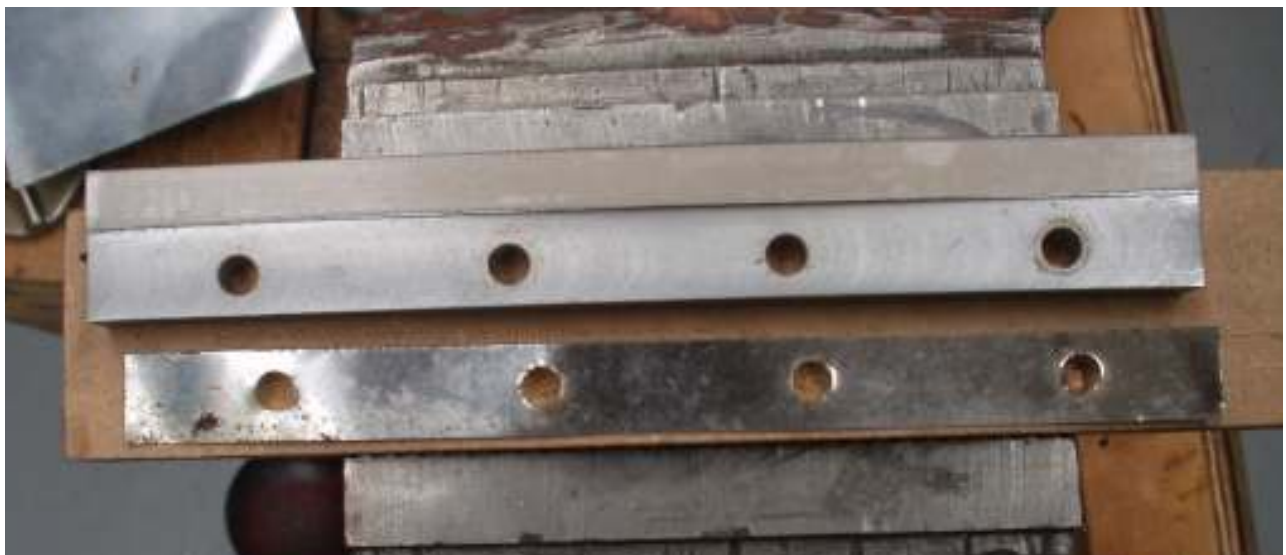
I cut one 0.016", two 0.006", two 0.004", and in the end had to cut a 0.0015" for the right side. The left side was fine without it.

Note in the above picture that the surface that will contact the ram has a strip of UHMW tape on it. Because the tape went onto an elevated surface, alignment was easy. Any tape that stuck out the ends was just trimmed off with my knife.

It did take some time to find the right combination of shims. When I got close, I blued the edges and top in order to find where there was a slight binding. A strip of 600 grit backed with a large parallel was used to smooth the trouble spots. I was careful to wipe off all grit and metal flecks because they can embed in the UHMW tape and cause damage.

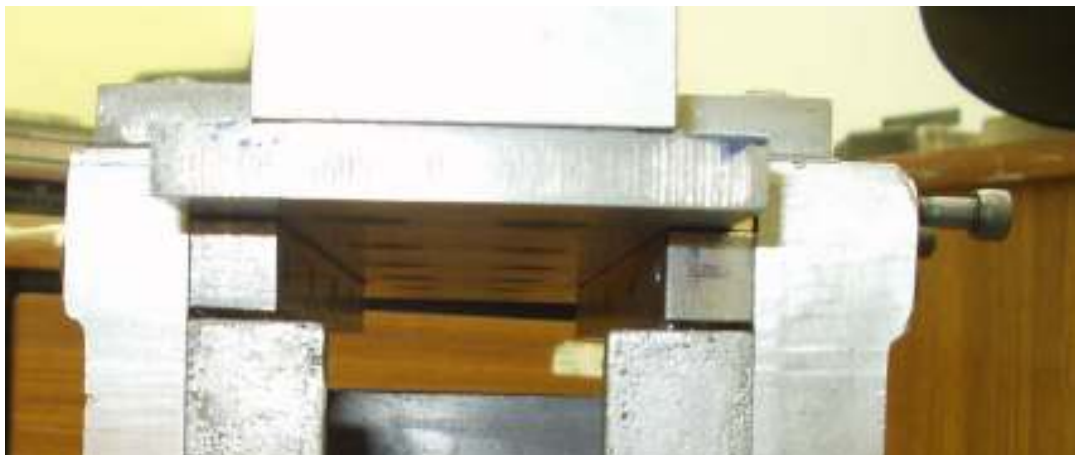
Sorry about the camera not being level, but you can clearly see the slide ways, brass gib on the right, and top clamps. The shims and UHMW tape are barely visible.

My ram now slides smoothly with no play.
