1964 Atlas/Craftsman Lathe Motor Supports, Version 1.0

By R. G. Sparber

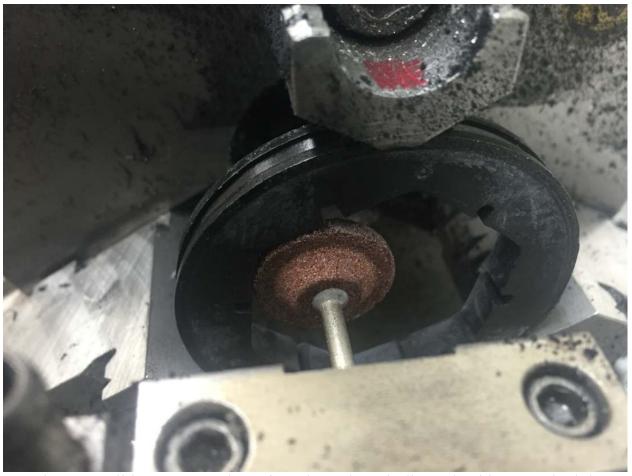
My Dremel was mounted in my toolpost using a support bar. A small grinding wheel was installed.

I set the cross slide to zero at the point where the grinding wheel just touched the minimum ID.

With the lathe running at around 100 RPM and the grinding wheel turning at 35,000 RPM, I took 0.01 inches per pass. In just a few minutes I was done with the ring.
